Left Rear Fascia Alignment

Classification	Repair Bulletin	Section/Group	10 - Body	Country/Region	North America
Year	2012	Model	Model S	Version	All

Some vehicles might have an excessive gap between the rear fascia and the left quarter panel.

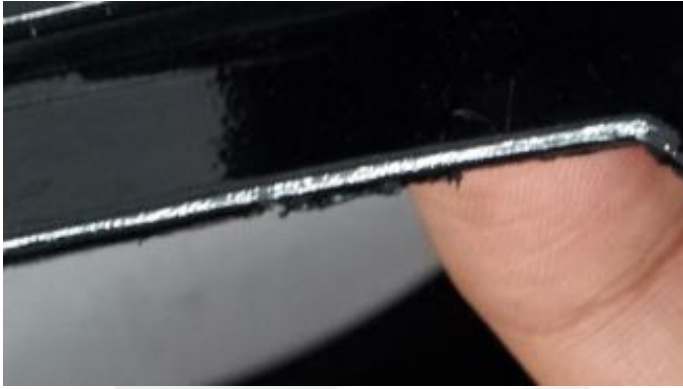
✓ **Figure 4 (Correct)**

NOTE: The shims must not protrude from the flange (Figures 4 and 5). If any shim protrudes, the fascia is prevented from sitting flush with the quarter panel.
