# High Power Wall Connector Fuse Upgrade

<b>Classification</b>	Repair Bulletin	<b>Section/Group</b>	50 - External Charging Connectors	<b>Country/Region</b>	North America
<b>Year</b>	All	<b>Model</b>	Model S	<b>Version</b>	All

This Service Bulletin supersedes SB-13-50-004 R2, dated 3-Jan-14. Each content change is marked by a vertical line in the left margin. Discard the previous version and replace it with this one.

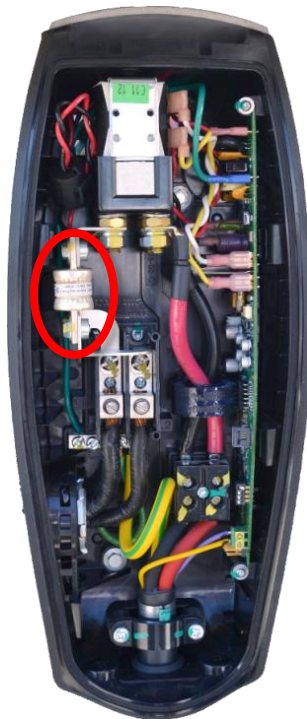
Figure 1 (HPWC with 100A fuses)

Transient current spikes can cause the high power wall connector (HPWC) fuses to blow. If the fuses are blown, the diagnostic lights (red or green) do not display on the front of the HPWC and electrical power is no longer available past the fuse. Vehicle logs might indicate no pilot signal and no charge when the user attempts to charge using the HPWC.

**NOTE:** This procedure only applies to HPWCs that require an upgrade from 100A fuses to 200A fuses (Figure 1). For information on replacing 200A fuses (Figure 2), refer to Service Manual Procedure 50020102.

Replace both fuses with upgraded components for customers that charge at 80A (customers that use a 100A circuit), or

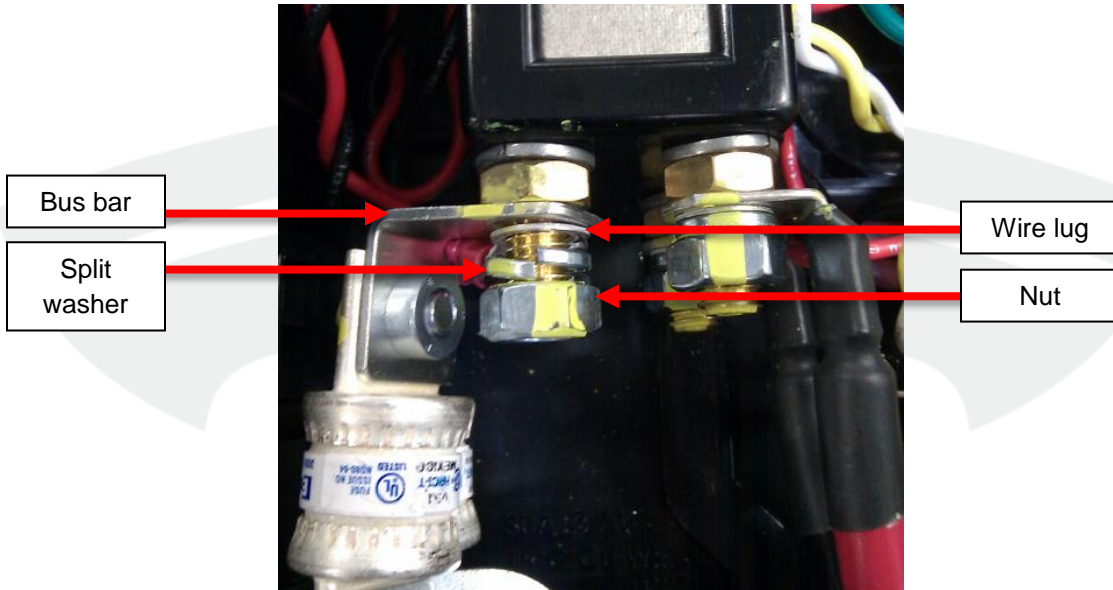
**Figure 7**

**⚠ CAUTION:** The locations of the red and black wires on the left-hand side of the contactor might differ, depending on the age of the HPWC. Note the color configuration of the wiring to the contactor before removal. Ensure that all wiring is installed to the same location.

- Before removing the fuse/bus bar assemblies completely, note the order of the components from bottom to top: nut, split washer, wire lug, bus bar (Figure 7).

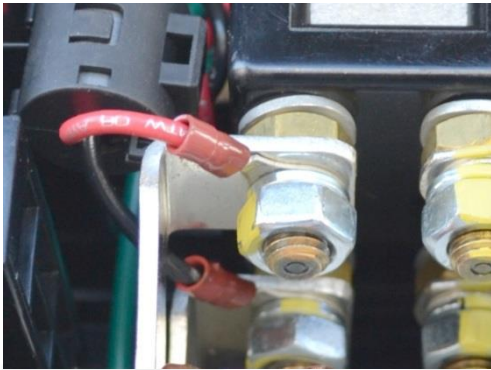
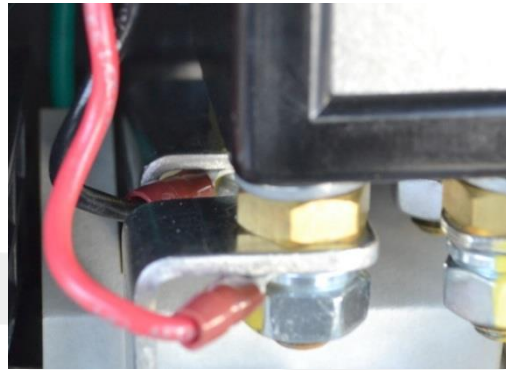
**⚠ CAUTION:** Clock both ring lugs so that the wires point toward the front of the unit at an approximate 45-degree angle, allowing a gap between the inner wire and the outer bus bar (Figures 11 and 12). The wires must not touch the bus bars directly.

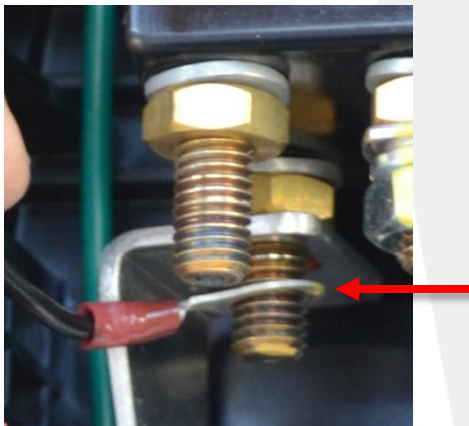
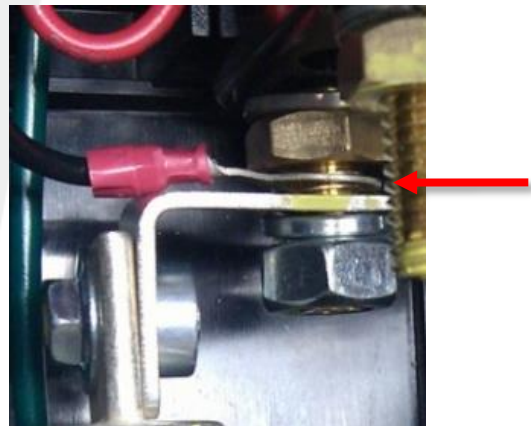
**⚠ CAUTION:** Always install the bus bar first and the ring lug second. Installing the ring lug first can result in excessive resistance and overheating (Figures 13 and 14).

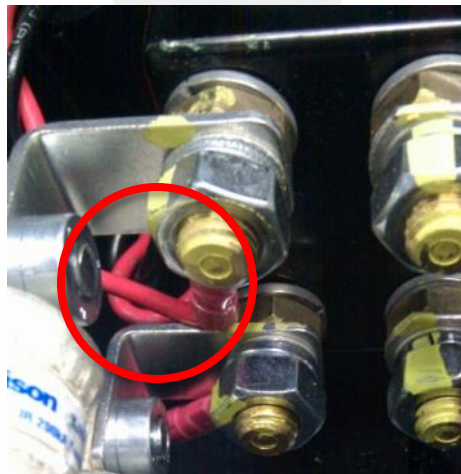
**✘ Figure 19 (Incorrect: resting on bus bar)**

Ensure that the ring lugs are correctly reinstalled to the same location they were before beginning this procedure. The wires must not rest on the bus bars (Figure 19).
