Exterior Mirror Corrosion

| Classification | Repair Bulletin | Section/Group | 12 - Exterior Fittings | Country/Region | North America and Europe |
| Year | 2012-2014 | Model | Model S | Version | All |

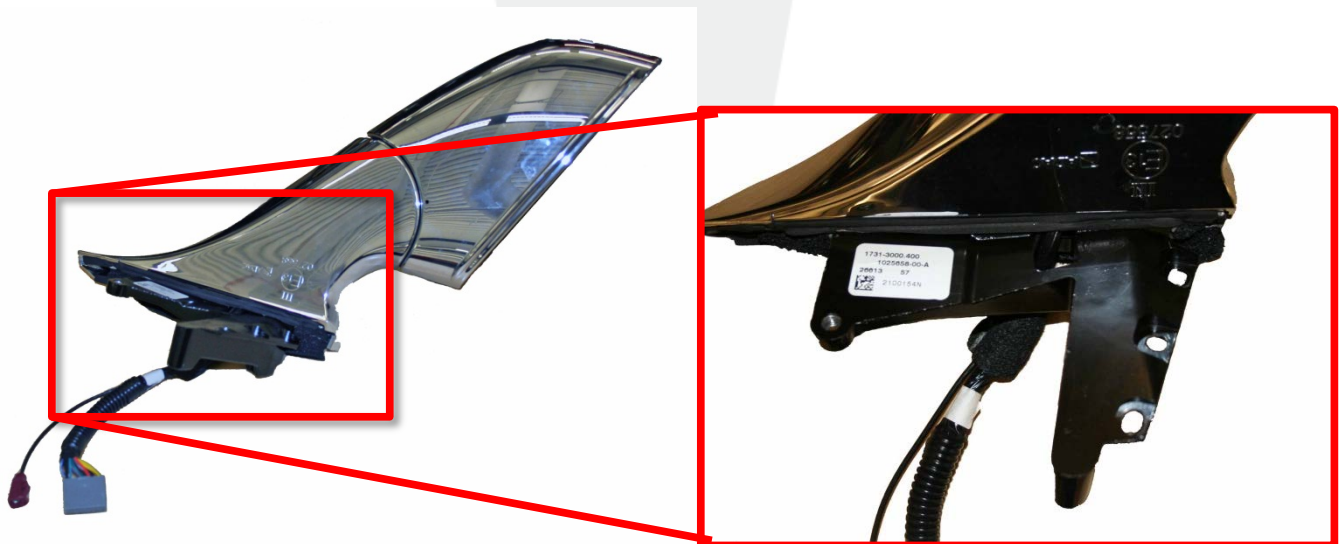
Figure 2

5. Inspect the replacement mirrors to ensure that the aluminum casting has black e-coating (Figure 2).
