Loose C-Pillar Brightwork

Classification	Repair Bulletin	Section/Group	12 - Exterior Fittings	Country/Region	All
Year	2013-2014	Model	Model S	Version	All

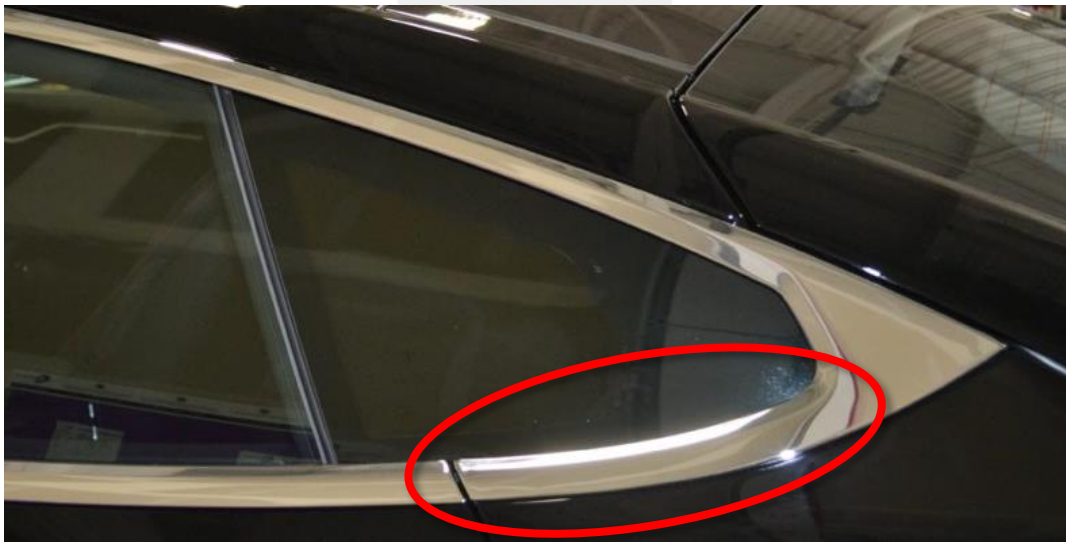
Figure 1

The Model S body side brightwork might become loose near the C-pillar on either side of the vehicle, causing a perceived quality issue (Figure 1).

Upon customer complaint of the body side brightwork becoming loose near the C-pillar, remove the body side brightwork, clean the window encapsulation and apply adhesives, then reinstall and clamp the body side brightwork.
