Panoramic Roof Bracket Creak

| Classification | Repair Bulletin | Section/Group | 24 - Roof | Country/Region | North America and Europe |
| Year | 2012-2013 | Model | Model S | Version | All |

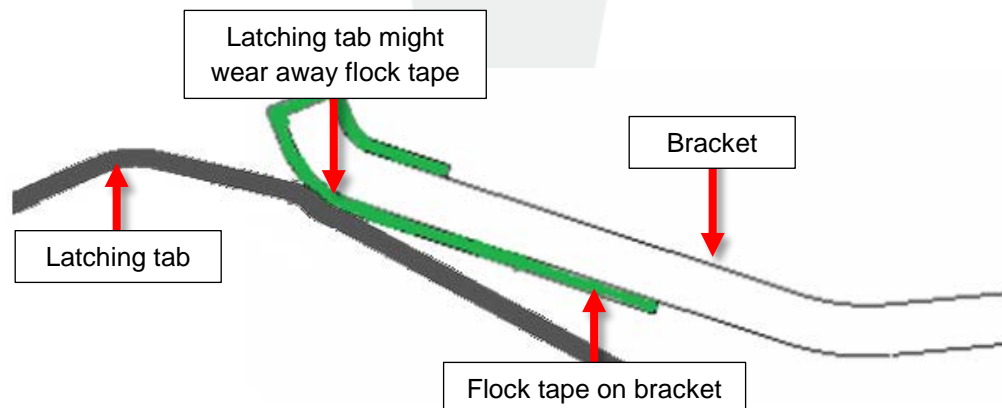
Figure 1 (Cross-section view of bracket and latching tab)

The section of the bracket that mates with the latching tab is covered in flock tape. However, over time as the roof opens and closes, the latching tab might wear away the flock tape (Figure 1).

When this happens, it is possible for the latching tab to rub against the metal bracket, which results in a creaking noise. The noise seems to come from the front of the moving glass, and is different from the panoramic roof creak that is described in SB-13-24-004, which seems to come from the rear of the moving glass.

Upon customer complaint, check for the presence of a metal bracket underneath the front applique. If equipped, ensure that the top of the latching tab is covered in anti-squeak tape.
