Panoramic Roof Rattling

Classification	Repair Bulletin	Section/Group	24 - Roof	Country/Region	All
Year	2013-2014	Model	Model S	Version	All

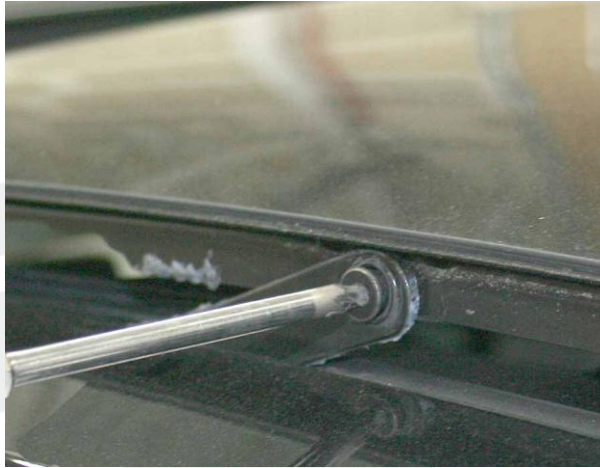
Figure 1 (Rear LH bolt shown)

In some vehicles, the panoramic roof might make a rattling sound when the vehicle is on a rough road and the moving glass is open.

1. Fully open the panoramic moving glass.
2. Remove 1 of the bolts that secure the moving glass to the link assemblies (torque 5 Nm) (Figure 1).
