NEMA 14-50 Wall Adapter Upgrade, U.S.

Classification	Recall Bulletin	Section/Group	50 - External Charging Connectors	Country/Region	United States
Year	2012 - 2014	Model	Model S	Version	All

This Service Bulletin supersedes SB-14-50-002, dated 20-Mar-14. Each content change is marked by a vertical line in the left margin. Discard the previous version and replace it with this one.

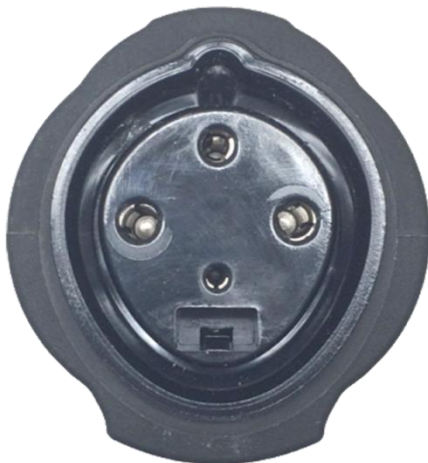
Factors such as corrosion, physical damage to receptacles, or the inappropriate wiring or installation of electrical outlets might cause higher than normal electrical resistance when charging with the Universal Mobile Connector (UMC) NEMA 14-50 adapter. When charging, higher-than-normal electrical resistance might cause excessive heating of the adapter.

Tesla Motors is recalling all black NEMA 14-50 adapters, which were included with all Model S vehicles that were delivered between September 15, 2012 and January 10, 2014. The new adapters with gray faces are not part of this recall.

Figure 1 (Old adapter with black faceplate)

Ensure that the vehicle has firmware version 5.8.4 or later. If the customer has not yet received the upgraded adapter by mail, provide the customer with an upgraded adapter if one is available in stock.

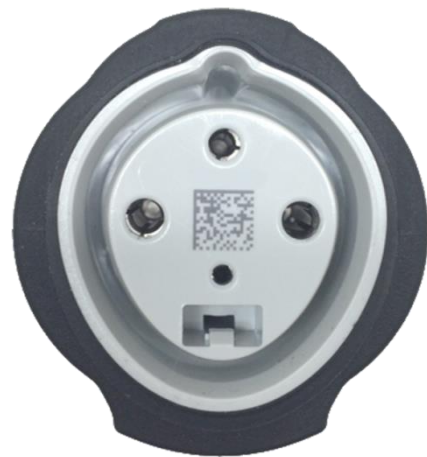
Figure 2 (New adapter with gray faceplate)
