Replace Aeroshield Support Tab, HV Battery 2.0

Classification	Repair Bulletin	Section/Group	16 - Battery System	Country/Region	All
Year	All	Model	Model S, Model X	Version	HV Battery 2.0

This Service Bulletin supersedes SB-15-16-003, dated 6-Nov-15. Each content change is marked by a vertical line in the left margin. Discard the previous version and replace it with this one.

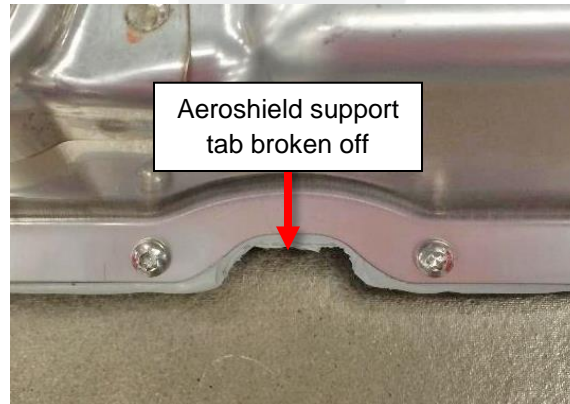
Figure 1

It is possible to accidentally break off the aeroshield support tab from the HV Battery (Figure 1). If the tab breaks, the mid aeroshield is not fully supported, reducing the aerodynamic efficiency of the vehicle. The operation of the HV Battery is not affected.

Replace the aeroshield support tab.
