Ensure Proper Clearance Between A/C Line and Brake Line

Classification	Campaign Bulletin	Section/Group	18 - Thermal Management	Country/Region	Asia Pacific, Europe
Year	2015	Model	Model S	Version	RHD Dual Motor

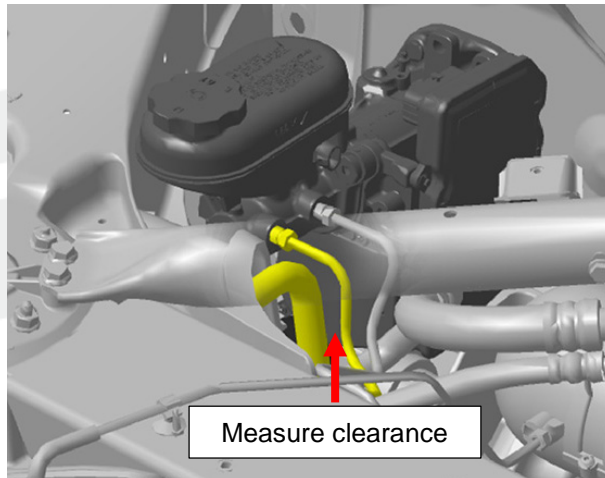
Figure 1

In some RHD Dual Motor Model S vehicles, there might not be sufficient clearance between the air conditioning (A/C) line and brake line bundle, which could cause a perceived quality issue with noise or vibration clearly evident to the driver. If allowed to persist, this could result in an A/C malfunction.

1. Remove the cowl screen (refer to Service Manual procedure 12250902).
2. Measure the distance between the A/C line and the front brake line (Figure 1):
 - If there is at least 5 mm of clearance, no additional work is needed. Discontinue this procedure and reinstall the cowl screen.
 - If there is less than 5 mm of clearance, continue this procedure.

7. Have an assistant monitor the clearance between the A/C line and brake line (Figure 1). Gently adjust the position of the A/C line until there is 5 mm of clearance.
8. Resecure the A/C line fasteners.
9. Inspect the brake lines near the booster. Replace the front brake line bundle if any of the following are true (refer to Service Manual procedure 33034502):
 - The rubber on the brake lines is worn
 - The brake lines touch each other
10. Reinstall all components that were removed for access.
