Replace Radio Antenna Amplifier, Europe

Classification Repair Bulletin **Section/Group** 21 - Infotainment **Country/Region** Europe

Year 2015 **Model** Model S **Version** All

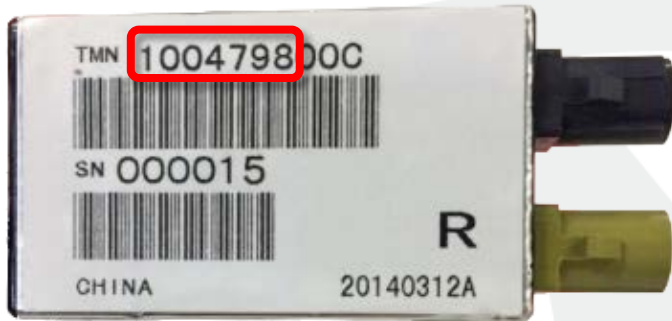
✓ Figure 1

1. Remove the RH liftgate trim (refer to Service Manual procedure 15111702).
2. Inspect the part number on the antenna amplifier:
 - If the base part number is 1004798 (Figure 1), no more work is required; reinstall the RH liftgate trim and discontinue this procedure.
 - If the base part number is anything other than 1004798 (Figure 2), replace the antenna amplifier (refer to Service Manual procedure 21300702).

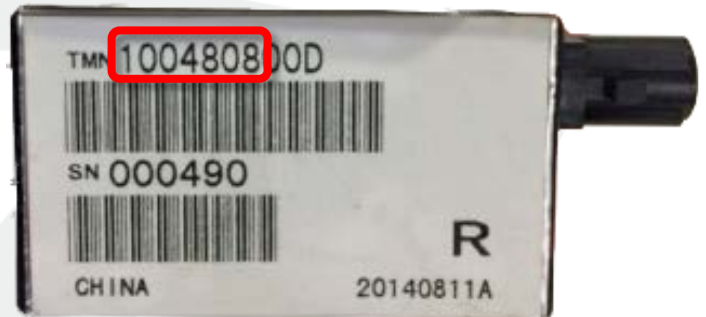
✗ Figure 2

Some European Model S vehicles were built with radio antenna amplifiers that are incapable of playing Digital Audio Broadcasting (DAB) radio.

Upon customer complaint of DAB radio not working, replace the radio antenna amplifier with one that is capable of playing DAB radio.
