# Replace Front Drive Unit to HVJB Harness

<b>Classification</b>	Campaign Bulletin	<b>Section/Group</b>	44 - High Voltage System	<b>Country/Region</b>	All
<b>Year</b>	2014	<b>Model</b>	Model S	<b>Version</b>	Dual Motor

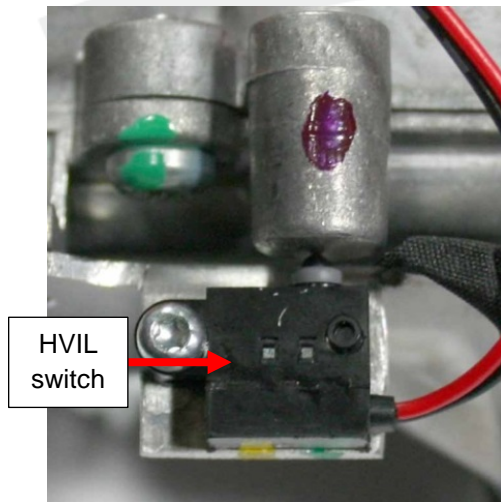
Figure 1

- If there is an HVIL switch (Figure 1) connected to a 12V HVIL connector (Figure 2), no additional work is required. Reinstall the 2<sup>nd</sup> row seat base frame and discontinue this procedure.
- If the fuse does not have an HVIL switch, continue this procedure.

3. Replace the HV harness that connects the front drive unit to the high voltage junction box (HVJB) (refer to Service Manual procedure 44500802).

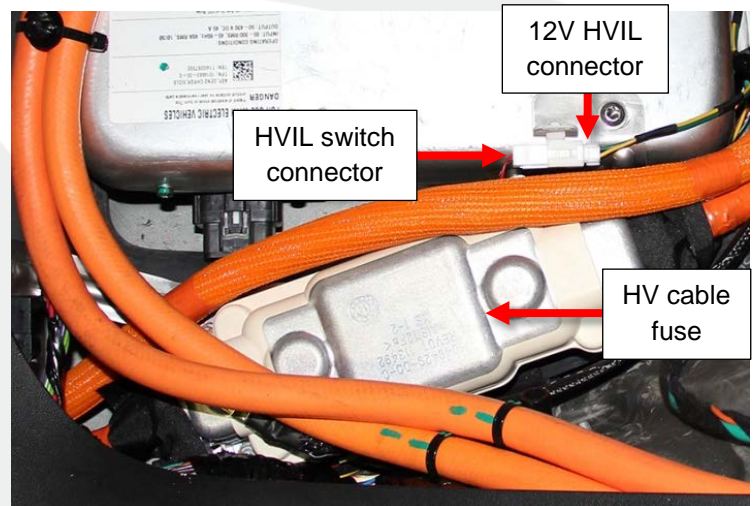
Figure 2

**NOTE:** If the vehicle does not have a 12V HVIL connector, contact Service Engineering.
