# Inspect Front Door Fixed Glass Seals

**Classification** Campaign Bulletin    **Section/Group** 11 - Closures    **Country/Region** United States

**Year** 2016    **Model** Model X    **Version** All

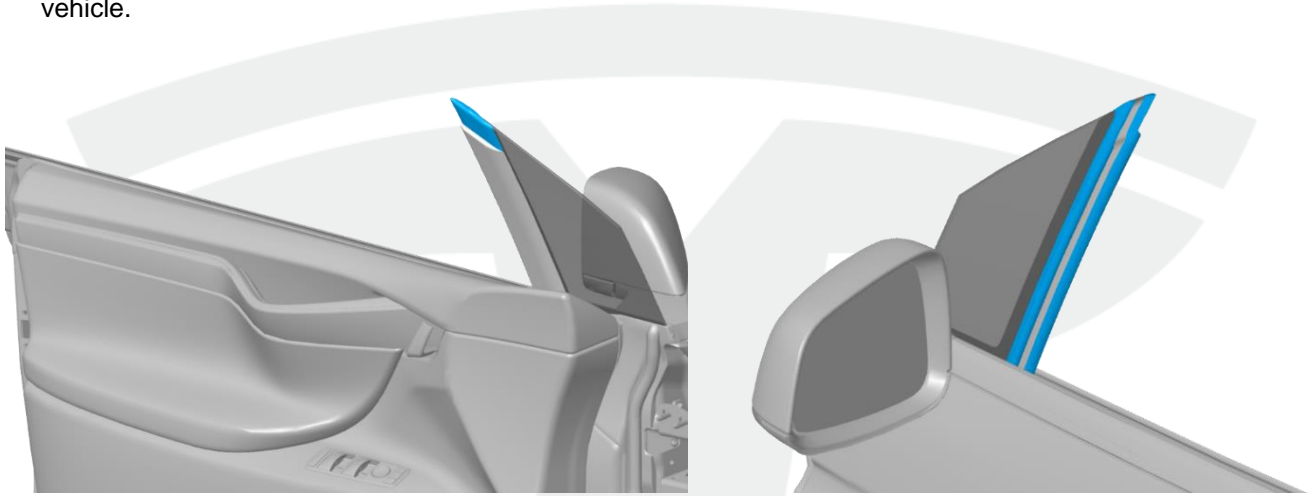
Figure 1

The seals on the front door fixed glass might have inadequate anti-wear coating, leading to premature wear. A worn seal might squeak when the door glass is moving or result in excessive wind noise.

1. Lower the LH front window.
2. Inspect the top of the inboard seal and both outboard seals on the front door fixed glass (Figures 1 and 2):
  - If the top of the inboard seal and the entire length of both outboard seals have a consistently gritty texture, the coating is adequate. Repeat the procedure on the RH side of the vehicle.
  - If any portion of the 3 seals has a smooth texture (Figure 3), the coating is inadequate. Replace the front door fixed glass (refer to Service Manual procedure 11501402), then repeat the procedure on the RH side of the vehicle.

Inspect the LH and RH front door fixed glass seals. If a seal has inadequate anti-wear coating, replace the front door fixed glass.
