## Inspect Position of A/C Condenser Pipes

<b>Classification</b>	Campaign Bulletin	<b>Section/Group</b>	18 - Thermal Management	<b>Country/Region</b>	All
<b>Year</b>	2016	<b>Model</b>	Model X	<b>Version</b>	All

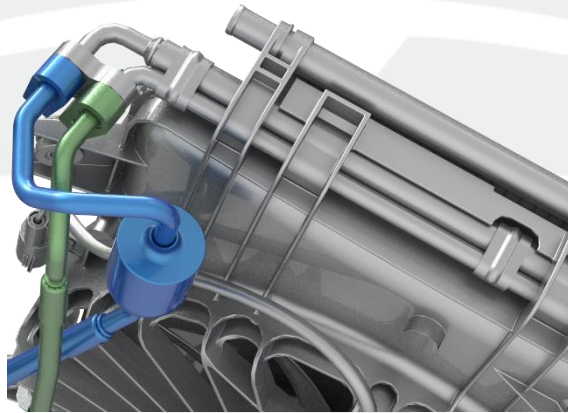
Figure 1

**NOTE:** The compressor discharge pipe (shown in blue) should be connected to the upper port on the condenser (Figure 1).

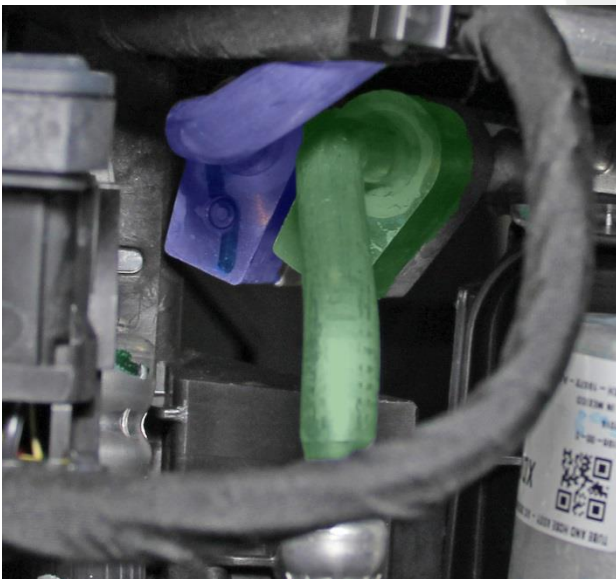
✓ Figure 2 (A/C condenser pipes highlighted)

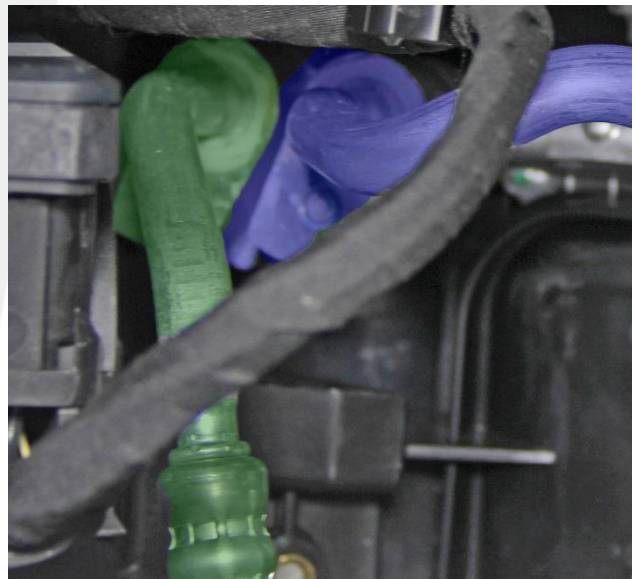
On some Model X vehicles, the A/C condenser pipes might have been installed on the incorrect condenser ports. This might cause poor or no A/C cooling performance, slow Supercharging, and/or noise from the condenser pipes touching the front suspension sway bar.

✗ Figure 3 (A/C condenser pipes highlighted)

3. Remove the mid aero shield panel (refer to Service Manual procedure 12030502).
4. Replace the desiccant bag (refer to Service Manual procedure 18202002).
5. Reinstall the lower front fascia.
