Active Spoiler Wind Noise

Classification	Campaign Bulletin	Section/Group	45 - Noise, Vibration & Harshness	Country/Region	United States
Year	2016	Model	Model X	Version	All

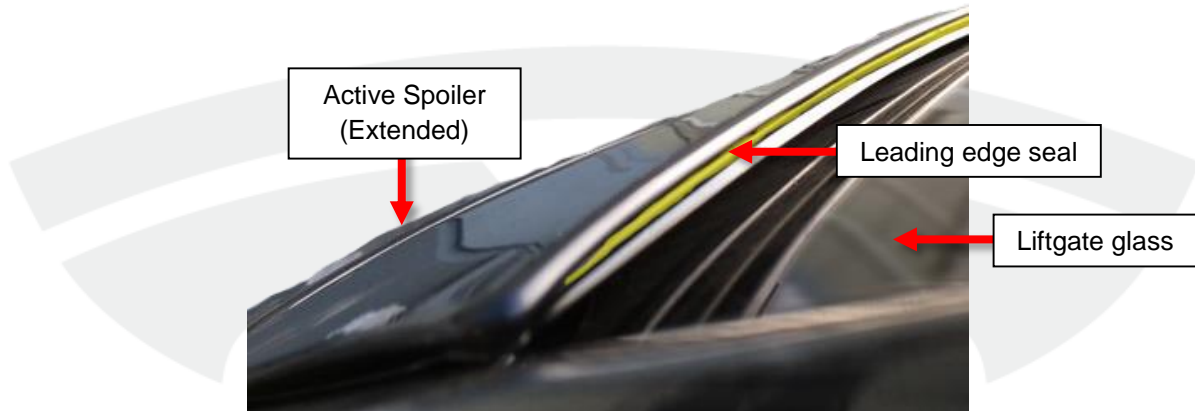
Figure 1 (Leading edge seal highlighted)

1. Extend the active spoiler.
2. Inspect the leading edge of the spoiler:
 - If a rubber seal is present on the leading edge (Figure 1), discontinue this procedure.
 - If a seal is not present, continue this procedure.

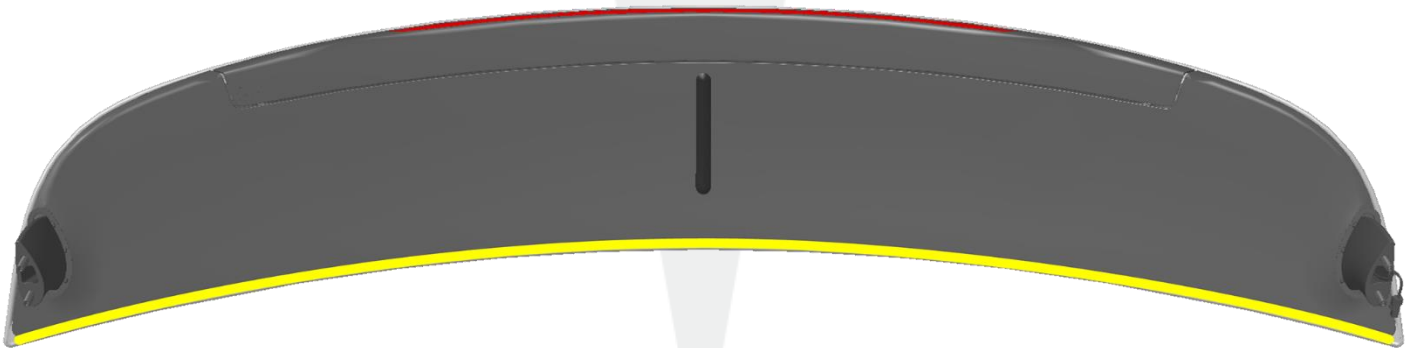
Figure 2 (Spoiler leading edge highlighted)

3. Prepare a soft, clean area on which to set the spoiler after it is removed.
4. Remove the active spoiler assembly (refer to Service Manual procedure 12220101) and place it upside down on the working area.
5. Use an alcohol wipe to clean the leading edge of the spoiler (Figure 2). Allow the area to dry before continuing.

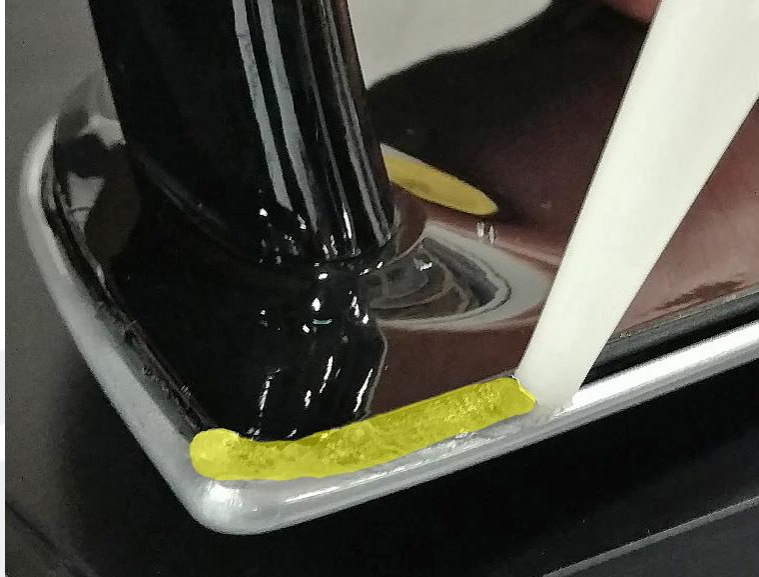
Figure 3 (Sealant bead highlighted)

6. Apply a 2-3 mm bead of Loctite 5510 clear sealant to the spoiler leading edge (Figure 3).

7. Use isopropanol on a gloved finger to smooth out the sealant bead.

NOTE: Ensure that the sealant covers the entire spoiler leading edge seam with no gaps.
