# Eliminate Gap Between Active Louver and Front Fascia to Improve A/C Performance

<b>Classification</b>	Repair Bulletin	<b>Section/Group</b>	18 - Thermal Management	<b>Country/Region</b>	All
<b>Year</b>	2016	<b>Model</b>	Model X	<b>Version</b>	All

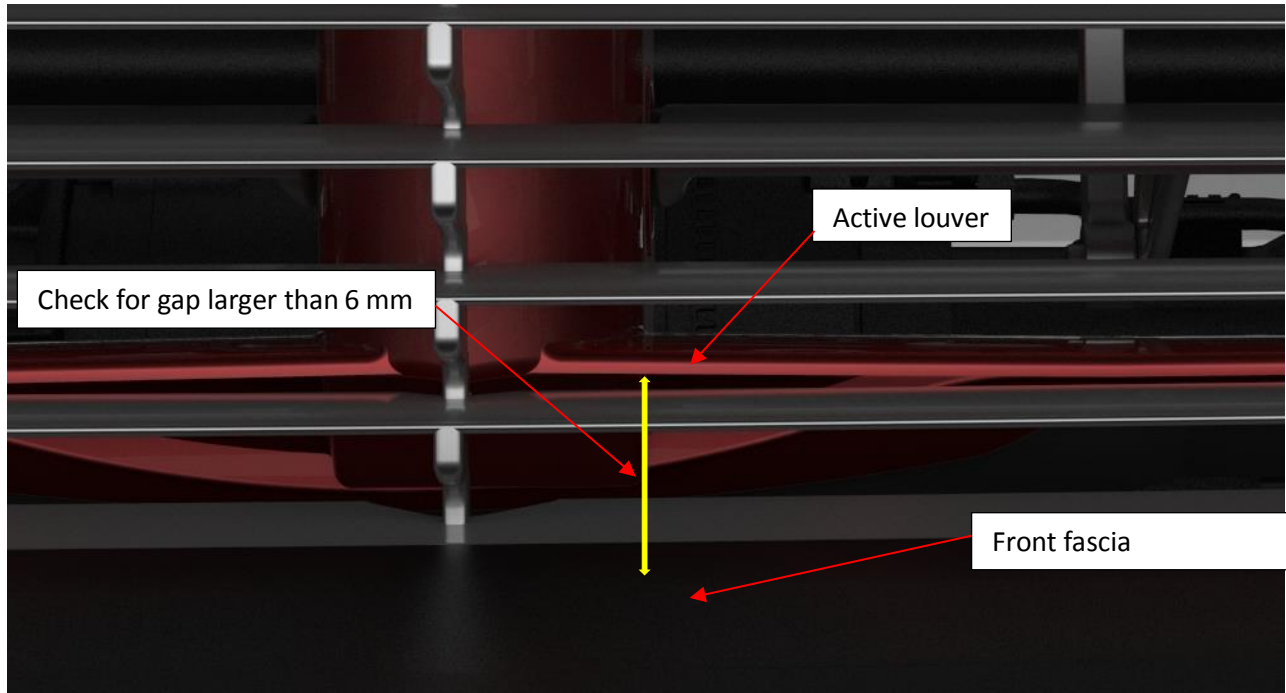
Figure 1

An excessive gap between the active louver and the front fascia might allow hot air to be pulled into the inlet of the A/C condenser, reducing A/C performance in high ambient temperatures.

1. Use a depth gauge to check the gap between the bottom of the active louver housing and the top of the front fascia opening (Figure 1).
  - If the gap is 6 mm or less, a seal is not required. Discontinue this procedure.
  - If the gap is greater than 6 mm, continue to the next step.
