# Install Butyl Rope On Lower Rear Doors

**Classification** Repair Bulletin      **Section/Group** 11 - Closures      **Country/Region** All

**Year** 2015-2018      **Model** Model X      **Version** All

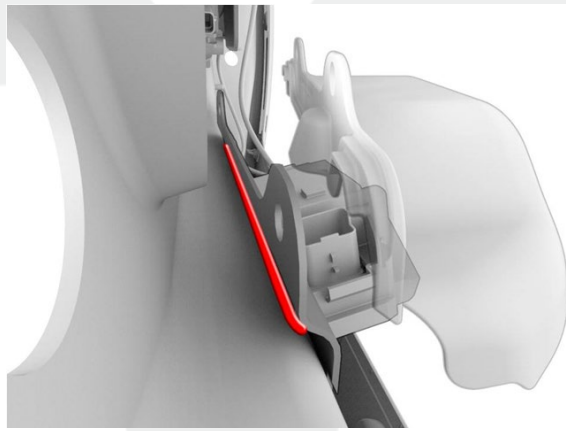
**Figure 1**

On some Model X vehicles, water might enter the door latches on the rear (Falcon Wing) doors, which can damage the electrical components integral to door latching operation.

1. Use a utility knife to cut 2 10 in (26 cm) long pieces of the butyl rope.
2. Remove the rear door trim panel (refer to Service Manual procedure 15132001).
3. Remove the rear door speaker.
4. If a rear door latch shroud is not currently installed, install a rear door latch shroud on the LH and RH side. Refer to SB-18-11-002, "Install Rear Door Latch Shroud".
5. Use isopropyl alcohol to clean the area between the latch reinforcement and the inner door skin.
6. Apply the butyl rope to the area between the latch reinforcement and the inner door skin as shown (Figure 1).
