# Replace Rear Air Spring Modules

**Classification** Campaign Bulletin    **Section/Group** 31 - Suspension    **Country/Region** All

**Year** 2018    **Model** Model X    **Version** All

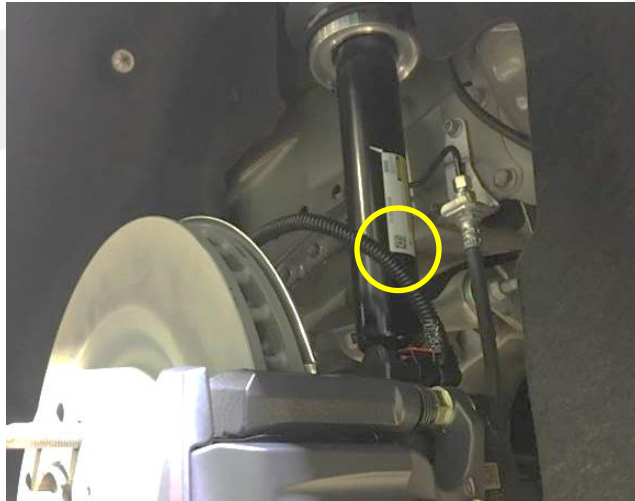
**Figure 1**

1. Remove the rear wheels (refer to Service Manual procedure 34012501).
2. Attach the scanner to a laptop.
3. Open the excel sheet, located [here](#):
  - a) Navigate to the 2<sup>nd</sup> tab in the excel spreadsheet. The tab is titled “**Scan here**”.
  - b) Select the 1<sup>st</sup> open cell in column B.
4. Scan the QR code located on the rear air spring module (Figure 1).The QR code appears in the cell selected in step 3b.

**NOTE:** Make sure that the barcode does not have any debris on it.

**TIP:** It might be necessary to use a mirror to scan the barcode.

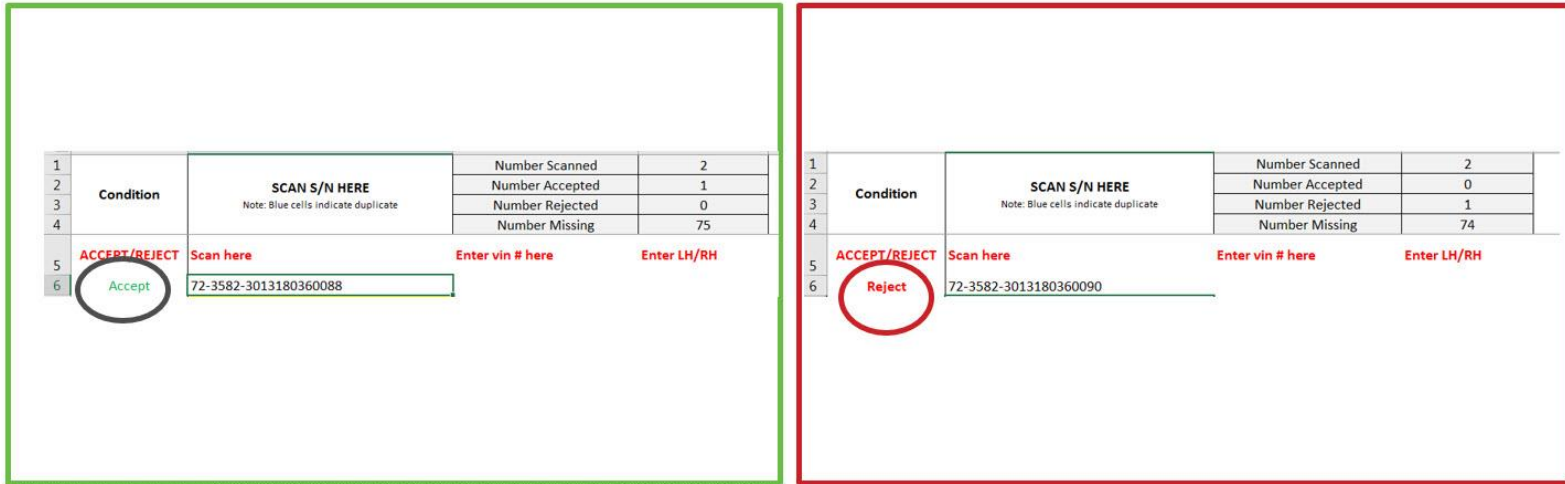
**Figure 2**

- If column A displays Reject (Figure 2), skip to step 6.
- If column A displays Accept, reinstall any component that was removed for access and discontinue this procedure.

6. Remove and replace the rear air spring module (refer to Service Manual procedure 31106002 for LH and 31106102 for RH)
7. Follow standard MRB and return instructions for any rejected air spring module.
