Install Rear Drive Unit Inverter Coolant Manifold Bolt

Classification	Campaign Bulletin	Section/Group	40 - Rear Drive Unit	Country/Region	United States
Year	2017	Model	Model 3	Version	All

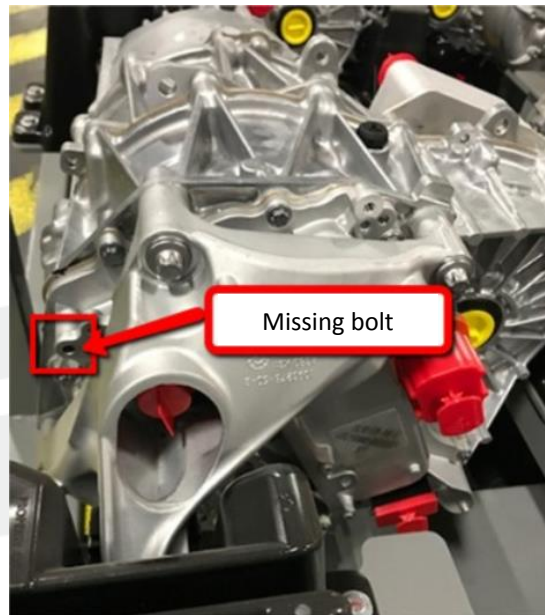
Figure 1

On some Model 3 vehicles, one of the bolts that helps to secure the rear drive unit inverter coolant manifold to the inverter housing might not have been installed. Consequently, coolant might leak from the manifold.

3. Take a photo of the rear drive unit inverter coolant manifold in the area between the LH side of the rear subframe assembly and the body, and upload the photo to Toolbox. Do this whether the bolt is installed or missing (Figure 1).

8. Install the bolt that secures the rear drive unit inverter coolant manifold to the inverter (torque 10 Nm).
9. Take a second photo after the bolt is installed, and upload the photo to Toolbox. Make sure that the newly-installed bolt is clearly visible in the photo.
