Replace Unscreened 2nd Generation Universal Mobile Connectors

Classification	Campaign Bulletin	Section/Group	50 - External Charging Connectors	Country/Region	North America
Year	2017-2018	Model	Model 3, Model X, Model S	Version	All

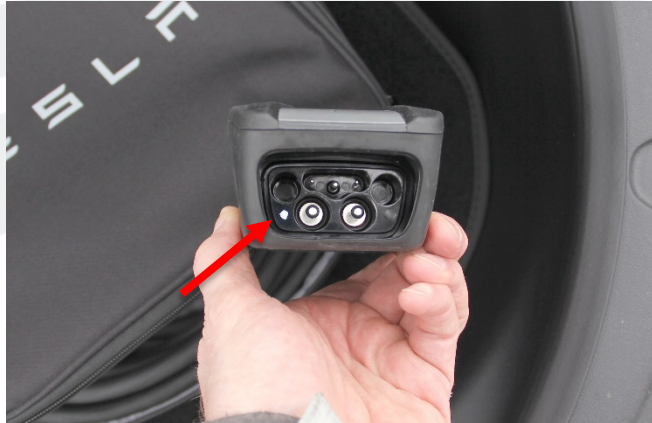
1. Disconnect the Smart Adapter from the vehicle's UMC.
2. Inspect the adapter receptacle on the body of the UMC (Figure 1).
 - If a silver paint mark is there, the UMC has been screened. Reconnect the Smart Adapter and discontinue this procedure.
 - If no silver paint mark is there, continue to the next step.

Figure 1 (Silver paint mark typical)

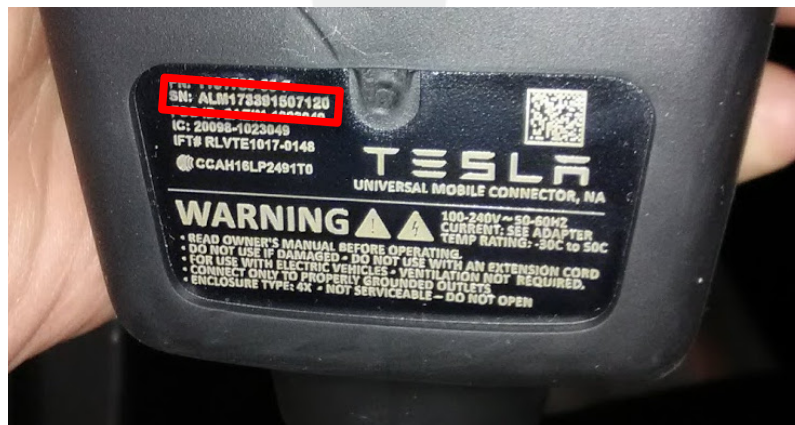
3. Inspect the serial number on the UMC label (Figure 2), and ignoring the first 3 characters (for example: ALM):
 - If the next 5 digits are greater than 17353, the UMC has been screened. Reconnect the Smart Adapter and discontinue this procedure.
 - If the next 5 digits are less than or equal to 17353, continue to the next step.

Figure 2 (5 Digits less than 17353)

4. Replace the UMC with a screened component.
5. Follow standard MRB and return instructions for any unscreened UMCs.
