Readjust Hood Latch

Classification	Campaign Bulletin	Section/Group	11 - Closures	Country/Region	United States, Canada
Year	2018	Model	Model 3	Version	All

On certain Model 3 vehicles, the hood latch might be out of alignment, causing a possible interference with the underhood storage unit.

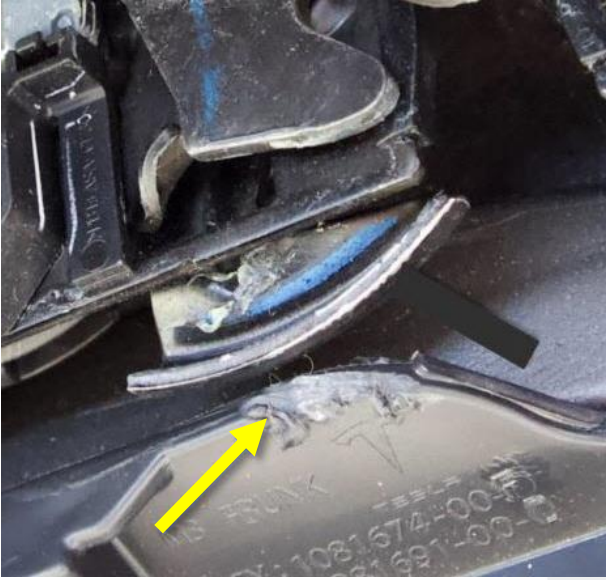
Figure 1 (Underhood storage unit damaged)

3. Draw a line on the underhood storage unit approximately 11.5 mm from the edge of the latch cutout (Figure 3), and then draw a line perpendicular right next to the curved feature (Figure 4)

4. Cut out and discard the marked sections of the underhood storage unit between the lines using diagonal cutters or similar tool (Figure 5).

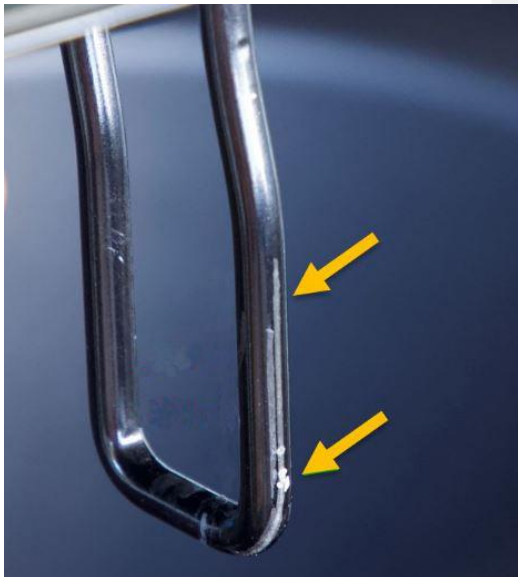
✘ Figure 6 (Visible scrape marks at the front of the hood latch striker)

14. Remove the bolts (x2) that attach the hood latch to the front end carrier (Figure 14).

15. Position 2 shims between the hood latch and the front end carrier (Figure 15), and then hand-tighten the LH hood latch bolt to the front end carrier. Repeat this step on the RH hood latch bolt.

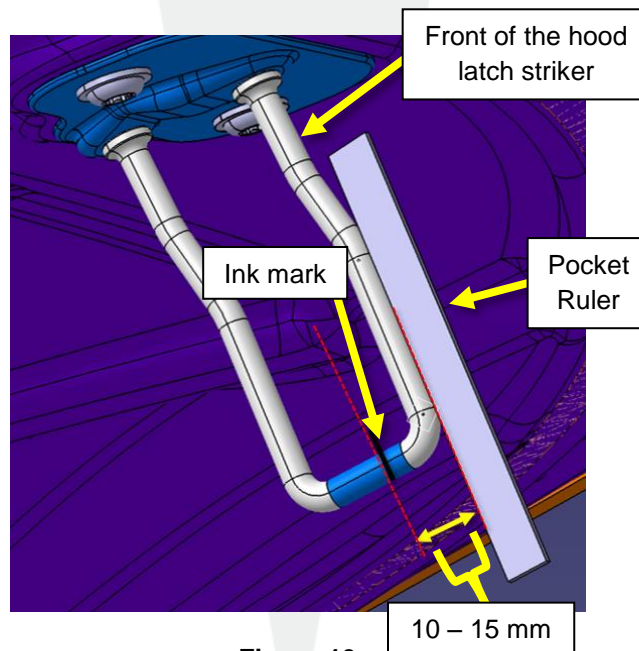
Figure 13

13. Measure the distance between the front of the hood latch striker and the ink mark left by the latch point on the hood latch using a pocket ruler and a digital caliper or ruler (Figure 13):

- If the measured distance is between 10 and 15 mm, remove the masking tape from the hood latch striker, and then go to step 19.
- If the measure distance is less than 10 mm, continue to the next step.

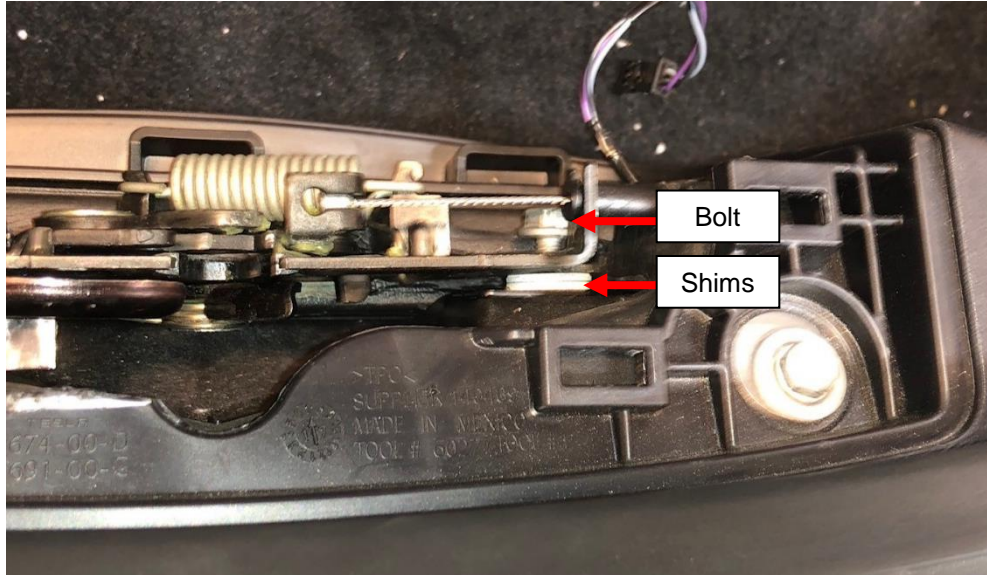
Figure 15 (LH hood latch bolt and shim, RH similar)

16. Push the hood latch assembly down fully, and then tighten the hood latch bolts (torque 8 Nm).
