Relocate Liftgate Electrical Wiring Harness

Classification Repair Bulletin **Section/Group** 17 - Electrical **Country/Region** All

Year 2015 - 2018 **Model** Model X **Version** All

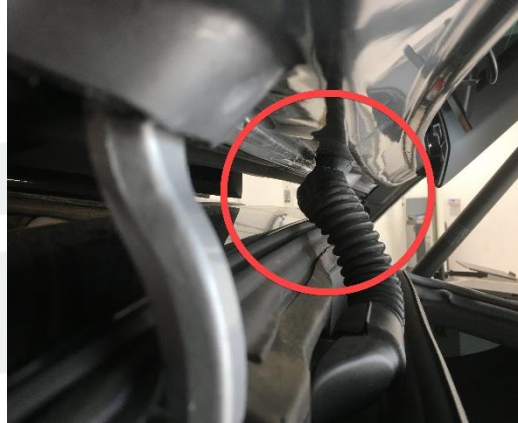
Figure 1

On some Model X vehicles, a pinched electrical wiring harness at the liftgate might create an obstruction alert, causing the power function of the liftgate not to operate. The liftgate can still be manually opened and closed. R1 changes the affected VIN dates.

1. Remove the liftgate upper trim panel (refer to Service Manual procedure 15111002).
2. Inspect the liftgate electrical wiring harness and pinch strip for signs of pinching of the liftgate electrical wiring harness between the liftgate and the body (Figure 1).

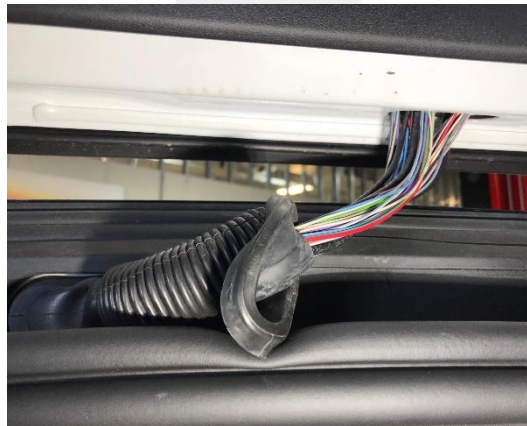
Figure 2

3. If signs of pinching are found, inspect for wiring damage that would warrant the replacement of the liftgate electrical wiring harness or pinch strip:
 - a. Remove the boot from the liftgate grommet hole, and then pull the boot back past the pinch area to investigate possible wiring damage (Figure 2).

- b. If wiring damage is found, discontinue this procedure and repair the electrical harness. Refer to SI-17-17-002, Electrical Harness Repair.

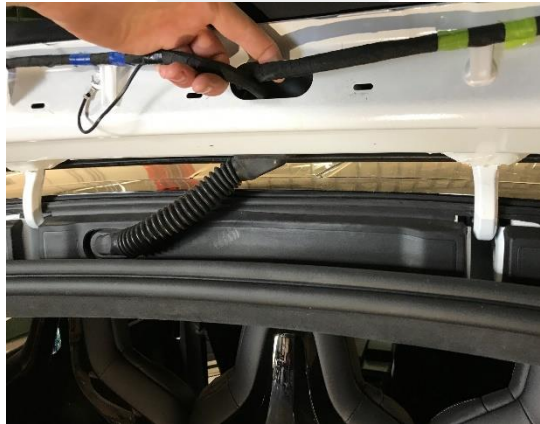
Figure 4

- 4. First visually inspect, then gently pull on the LH and RH legs of the liftgate electrical wiring harness from inside the liftgate opening to check for excess harness length, which might cause the boot and harness to be pushed into the pinch space between the body and liftgate (Figure 4). If excess slack in the harness is causing the liftgate electrical wiring harness and boot to be pushed into the pinch space, proceed with the “Relocate” procedure.
