| <b>Tesla, Inc.</b><br><b>Service Bulletin</b> | | <h2>Replace 2<sup>nd</sup> Row Seat Back Panels</h2> | |
| <b>SB-20-13-003</b><br>April 9, 2020 | | | |
| <b>Model Year</b><br>2020 | <b>Model</b><br>Model Y | <b>Country/Region</b><br>North America | <b>Version</b><br>All |

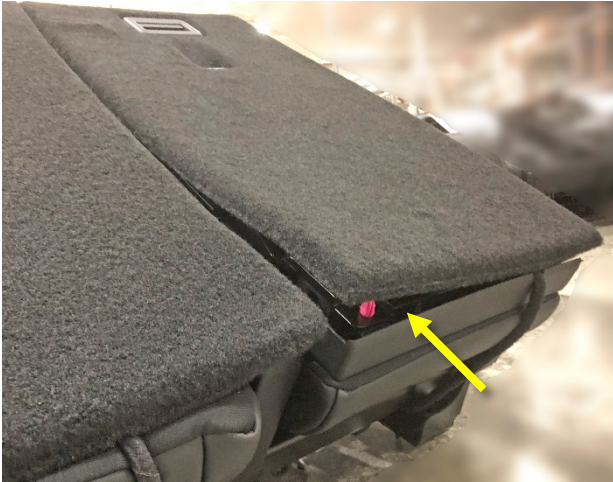
Certain Model Y vehicles might have been built with 2<sup>nd</sup> row seat back panels (left, center, and right) that did not meet internal specifications, resulting in the panels not being flush with the 2<sup>nd</sup> row seat.

**✘ Figure 1 – Example of excessive gap between center seat back panel and seat**

3. Replace all affected seat back panels:
  - **LH (60) 2<sup>nd</sup> row seat back panel:** Refer to Service Manual procedure [13082302](#).
  - **RH (40) 2<sup>nd</sup> row seat back panel:** Refer to Service Manual procedure [13082312](#).
  - **Center (20) 2<sup>nd</sup> row seat back panel:** Refer to Service Manual procedure [13082322](#).
4. Close the liftgate and both rear doors.

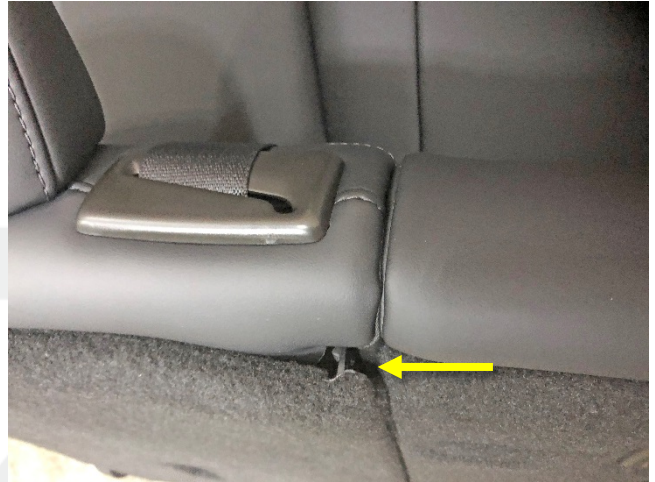
**✘ Figure 2 – Example of excessive gap between LH seat back panel and seat**
