<b>Tesla, Inc.</b> Service Bulletin		<b>Reseal Front Upper Control Arm Ball Joints</b>	
<b>SB-20-31-006</b> July 2, 2021		<b>R3</b>			
<b>Classification</b>		<b>Section/Group</b>		<b>Mobile Service</b>	
Campaign Bulletin		31 - Suspension		Can Perform (where permitted)	
<b>Model Year</b>	<b>Model</b>	<b>Country/Region</b>		<b>Version</b>	
2018 - 2020	Model X, Model 3, Model Y	All		All	
The model(s) and model year(s) listed are a general approximation of the affected VIN list. Refer to the VIN/Bulletin Tracker or Customer/Vehicle profile to determine applicability of this bulletin for a particular vehicle.

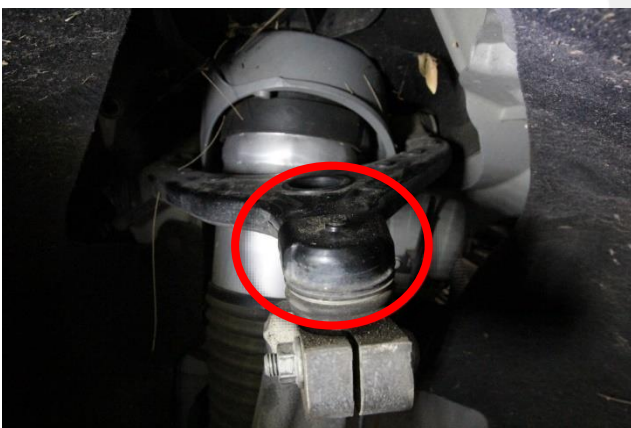
Figure 1

1. Raise the vehicle on a 2 post lift to a comfortable working height (refer to Service Manual procedure 10000205; [Model X](#), [Model 3](#), [Model Y](#)).
2. Thoroughly clean the areas surrounding the LH front upper control arm ball joint shown in Figures 1–5 with brake cleaner and a clean shop towel or an IPA wipe. If necessary, use a nylon brush to clean the area.
