Tesla, Inc. Service Bulletin		<h2 style="margin: 0;">Inspect Upper Steering Column Bolt</h2>	
SB-20-32-007 April 29, 2020			
Classification		Section/Group	Mobile Service
Campaign Bulletin		32 - Steering	Can Perform (where permitted)
Model Year	Model	Country/Region	Version
2020	Model 3, Model Y	All	All
<small>The model(s) and model year(s) listed are a general approximation of the affected VIN list. Refer to the VIN/Bulletin Tracker or Customer/Vehicle profile to determine applicability of this bulletin for a particular vehicle.</small>

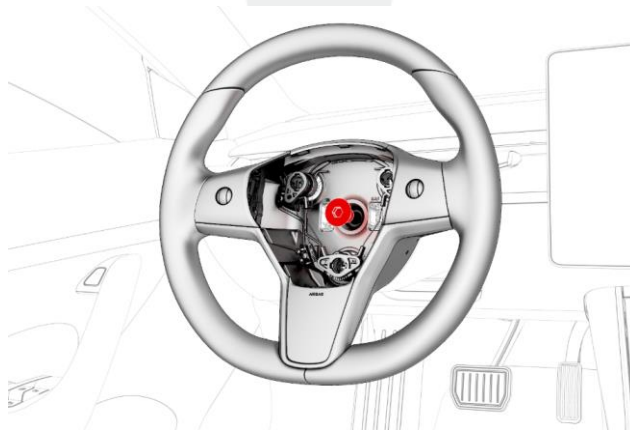
Figure 1

On some Model 3 and Model Y vehicles, the upper steering column bolt may not be installed according to internal specifications, which could cause excessive play between the steering wheel and steering column.

📄 NOTE: When installing the steering wheel, install a new bolt that attaches the steering wheel to the steering column (Figure 1) (torque 80 Nm).
