Tesla, Inc. Service Bulletin		<h2>Rework LH Door Mirror</h2>	
SB-21-12-003 April 23, 2021			
Classification		Section/Group	Mobile Service
Repair Bulletin		12 - Exterior Fittings	Can Perform (where permitted)
Model Year	Model	Country/Region	Version
2020-2021	Model Y	North America	All
<small>The model(s) and model year(s) listed are a general approximation of the affected VIN list. Refer to the VIN/Bulletin Tracker or Customer/Vehicle profile to determine applicability of this bulletin for a particular vehicle.</small>

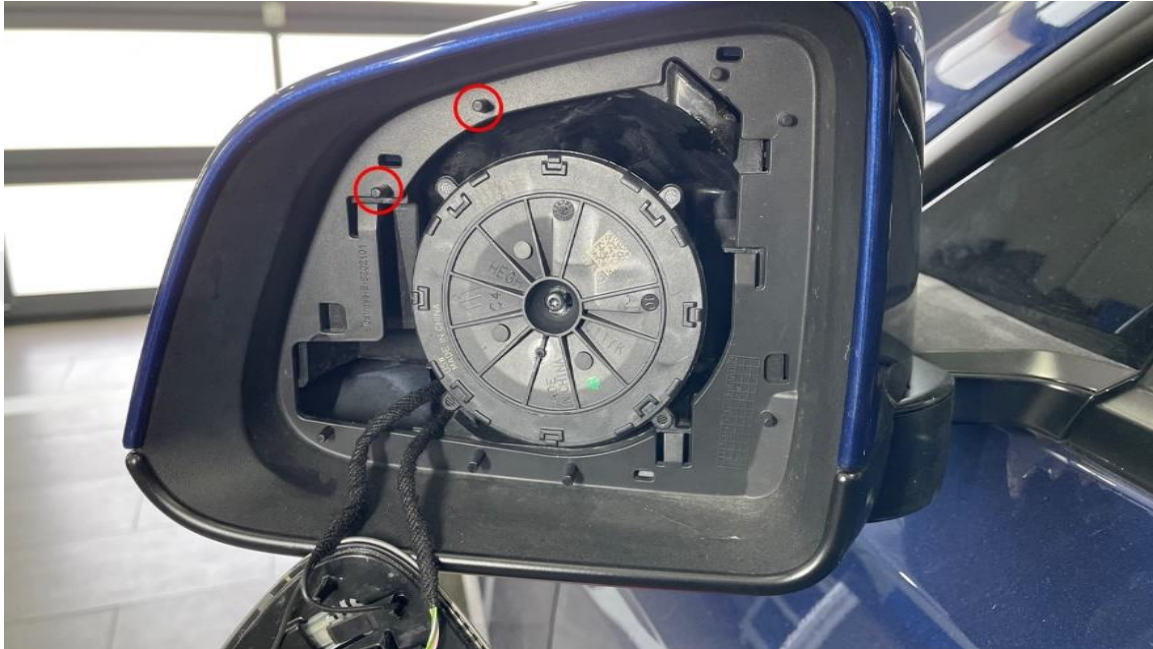
Some Model Y vehicles equipped with auto-dimming door mirror glass have difficulty adjusting the LH door mirror to extreme vertical angles.

Figure 1 – Standoffs shown

1. Remove the LH door mirror glass (refer to Service Manual procedure [12092002](#)).
2. Use diagonal cutters to cut off the LH door mirror glass standoffs (Figures 1 and 2).

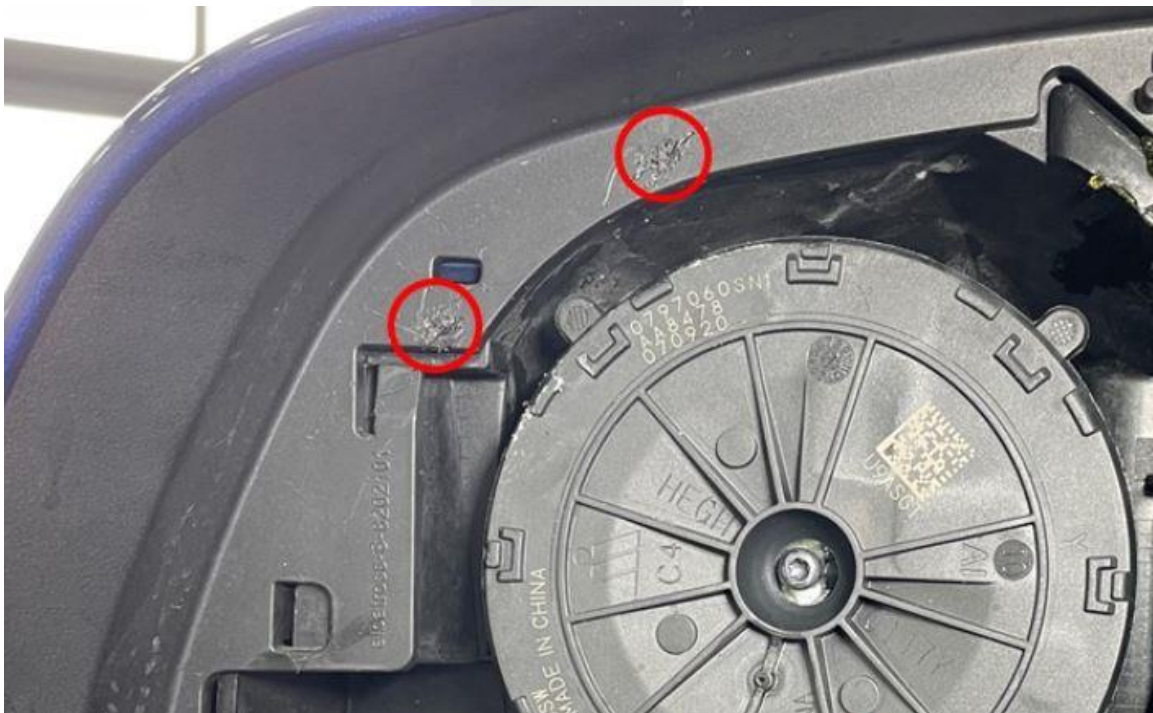
Figure 2 – Standoffs removed
