Tesla, Inc. Service Bulletin	Reseal HV Battery Platter	
SB-21-16-002 May 25, 2021				
Classification		Section/Group		Mobile Service
Campaign Bulletin		16 - HV Battery System		Cannot Perform
Model Year	Model	Country/Region		Version
2020 – 2021	Model 3	China		All
The model(s) and model year(s) listed are a general approximation of the affected VIN list. Refer to the VIN/Bulletin Tracker or Customer/Vehicle profile to determine applicability of this bulletin for a particular vehicle.

HV batteries sealing performance of certain Model 3 vehicles built at Giga Shanghai might need to be improved.

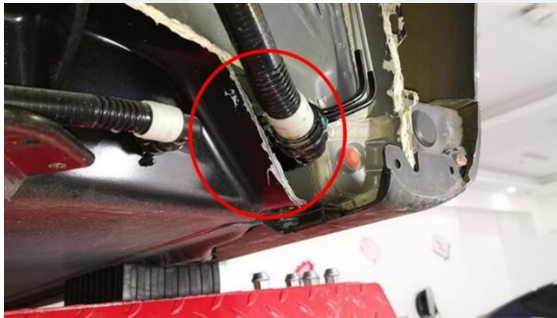
Figure 1 - LH front corner shown , LH rear corner similar

1. Remove the mid aero shield (refer to Service Manual procedure [12030502](#)).
2. Remove the front aero shield panel (refer to Service Manual procedure [12030102](#) and [1201102](#)).
3. Remove 4 wheel arch liners (refer to Service Manual procedure [12010902](#)).
4. Use an IPA wipe to clean the HV battery housing seam at the 4 primary corners, and then allow at least 1 minute to dry (Figures 1 and 2).

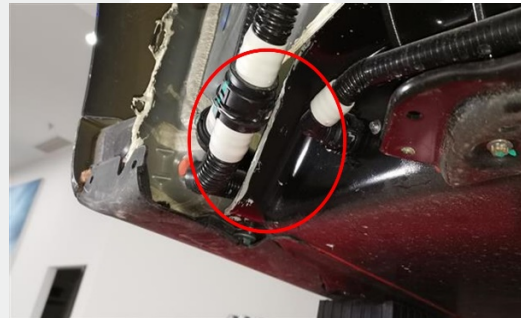
Figure 2 - RH front corner shown, RH rear corner similar

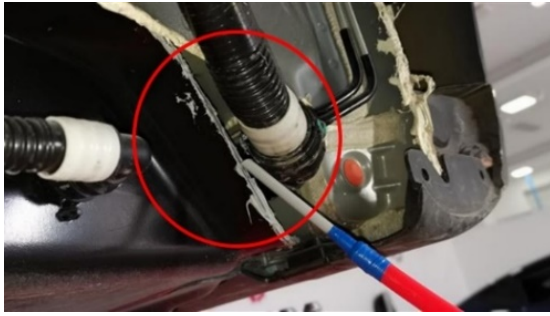
Figure 4 - LH front corner shown, LH rear corner similar

5. Apply an ample bead of sealant to the HV battery housing seam at the 4 primary corners, filling in any voids or cracks (Figures 3, 4 and 5).

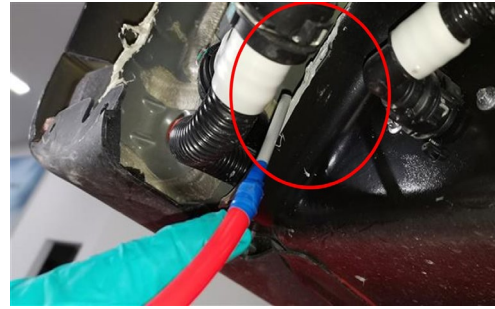
Figure 5 - RH front corner shown, RH rear corner similar
