Retrofit the Trunk Lid Harness

SB-21-17-008
April 30, 2022

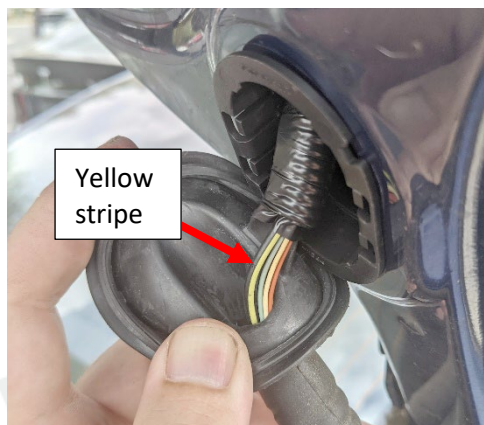
2. Release the rubber armor from the trunk lid, and inspect the coax cable within the armor (Figures 1 and 2).
 - **If the coax cable has a yellow stripe** - Replace the trunk lid harness (refer to Service Manual procedure [17104502](#)). Discontinue this procedure and use correction code S022117008.
 - **If the coax cable is all black** - Fasten the rubber armor to the trunk lid and go to the next step.

Figure 1 – Coaxial cable with yellow stripe

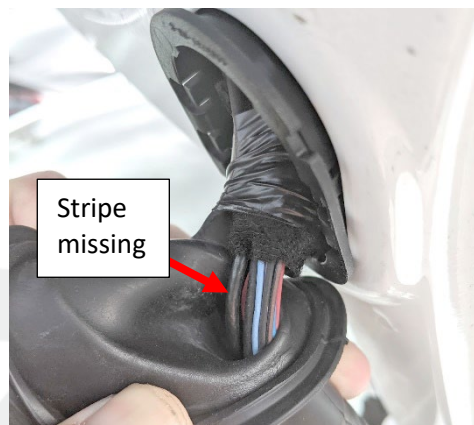
Figure 2 – Coaxial cable without yellow stripe
