Tesla, Inc.
Service Bulletin

Swap Triple Camera Coax Cables

SB-22-17-007
May 16, 2022

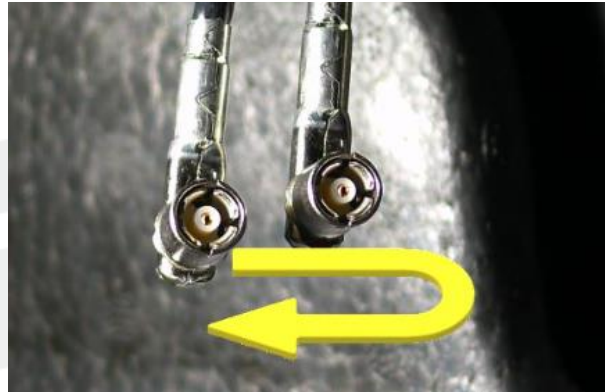
Figure 9

Certain Model 3 and Model Y vehicles were equipped with camera harnesses that were not manufactured to internal specifications, resulting in swapped views from the forward-facing fisheye and narrow view cameras. This condition causes Autopilot features to become unavailable.

9. Swap the positions of the coax cables (Figure 9), and then install the cables in the connector housing (Figures 10 and 11).

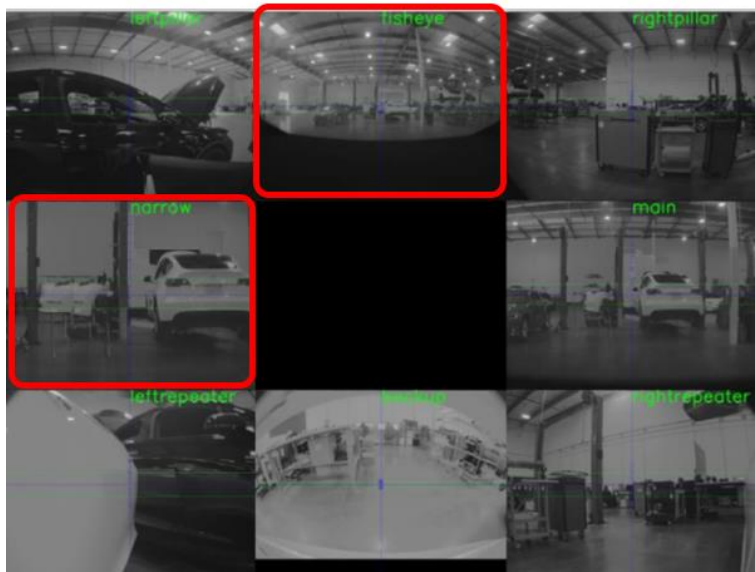
Figure 15

**NOTE:** The “narrow” view should appear magnified, and the “fisheye” view should appear wide-angled.

17. Select **DAS Image Capture**.
18. After the image loads, review the image to confirm that the cable swap was successful (Figure 15).
