Model: Model S

Vehicle System: 45 - Noise, Vibration & Harshness

Tech Note: A-Pillar Wind Noise Diagnostic Guide

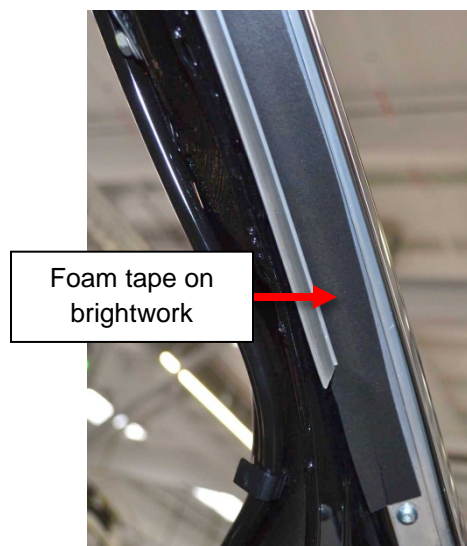
Figure 1

Gap Between Primary Body Seal and Brightwork

Desired condition: The gap between the primary body seal and the brightwork is padded with foam tape (Figure 1).

Inspection/Correction: Determine whether SB-13-12-005, “A-Pillar Wind Noise” is applicable to the vehicle. If so, perform the bulletin.

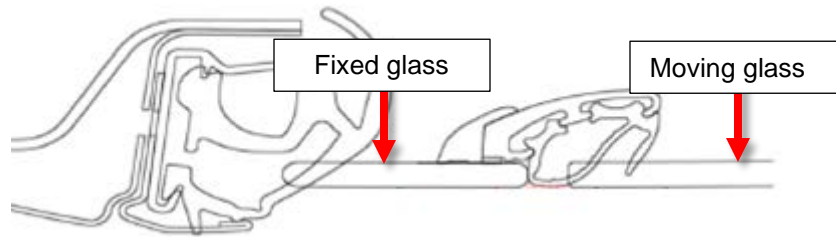
Figure 2 (View from above door)

Moving Glass and Fixed Quarter Glass Not Flush

Desired condition: The fixed glass and sliding glass are flush within 1 mm (Figure 2).

Inspection/Correction: Measure the flushness of the fixed and moving glass, as close to the seal as possible. If the fixed glass is underflush to the moving glass, pull outward carefully but firmly on the fixed glass (Figure 3). This bends the inner door panel and moves the fixed glass outward.

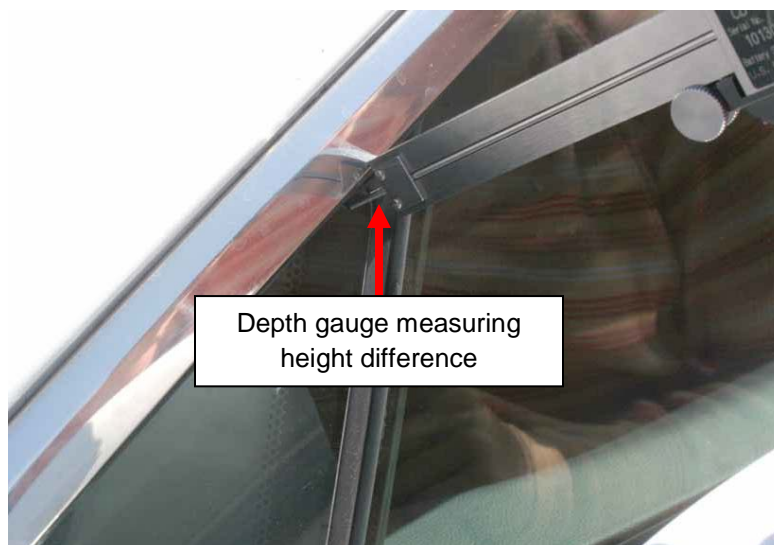
Figure 4

⚠ CAUTION: To prevent water leaks, the height difference between the highest point on the brightwork and the surface of the fixed glass must be 7.5 mm or less (Figure 4).

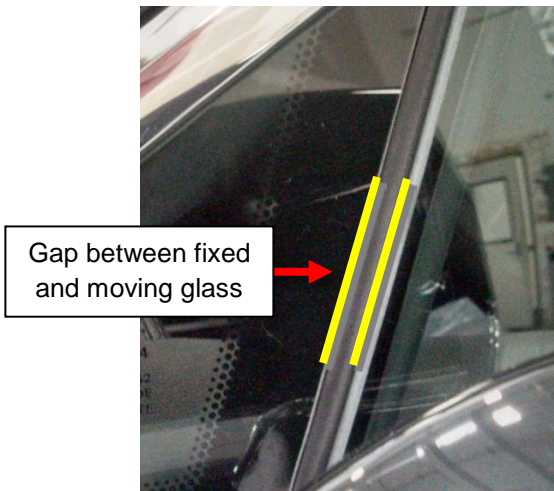
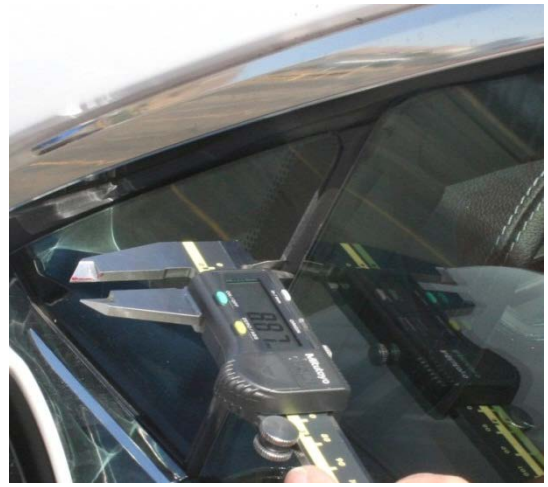
Gap Between Fixed and Moving Glass

Desired condition: The gap between the fixed and moving glass is 8 mm +/-1 mm (Figures 5 and 6).

Inspection/Correction: Adjust the moving glass (refer to Service Manual procedure 11500100). Ensure that the moving glass is not adjusted too far forward by putting a stiff plastic card, such as a credit card, between the rear edge of the moving glass and the B-Pillar. The card should remain in place without sliding down or falling out.

⚠ CAUTION: The maximum allowable distance between the rear edge of the moving glass and the B-Pillar applique is 12 mm.

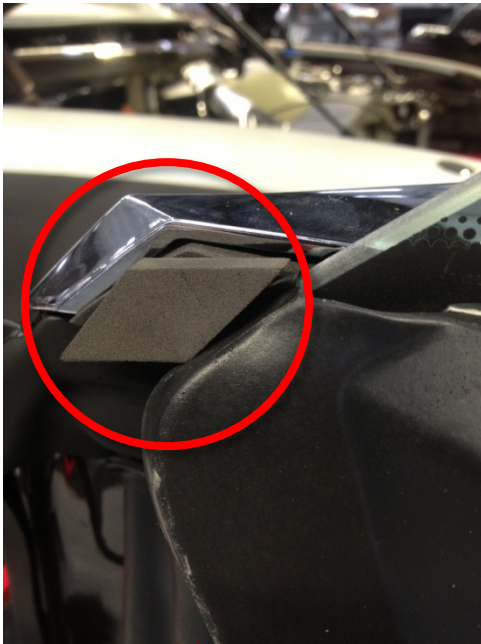
✘ Incorrect
Figure 7

Exterior Mirror NVH Foam Not Present

Desired condition: The diamond-shaped area in front of the fixed glass is padded with foam that is flush with the glass.

1. From inside the vehicle, inspect the diamond-shaped area in front of the fixed glass. If NVH foam is present in this area, and the foam is flush with the inboard edge of the glass, skip to the next section.
2. Affix the NVH foam (LH: 1022111-00-A, RH: 1022112-00-A) to the area in front of the fixed glass. If the foam is not flush with the inboard edge of the glass (Figure 7), repeat this step and affix the new foam on top of the first. Ensure that the foam fits the area as closely as possible (Figure 8).

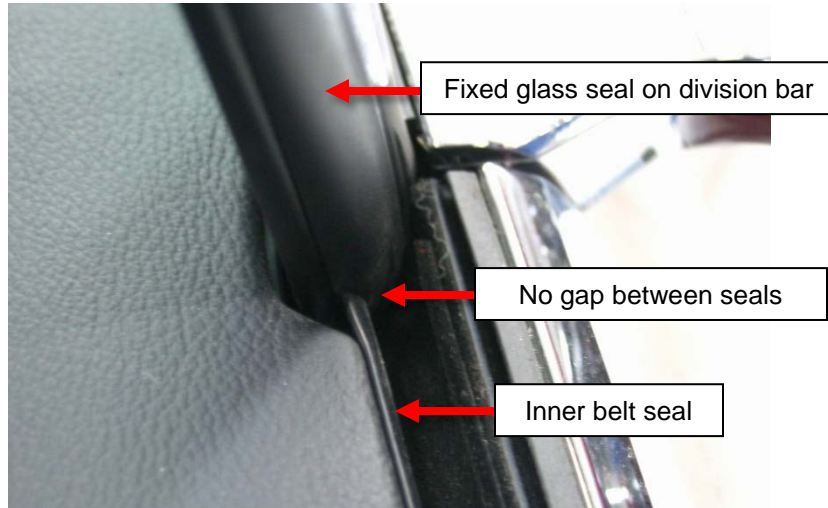
Figure 9

Inner and Outer Belt Seals Misaligned

Desired condition: The inner belt seal is flush with the seal on the division bar between the fixed and moving glass (Figure 9).

1. Move the inner belt seal until it is touching the division bar between the sliding and fixed glass (Refer to Service Manual procedure 11704202 to move the inner belt seal).
2. Pull up on the door brightwork and move it forward until there is a 1 mm gap between the door brightwork and the mirror brightwork (Figure 10). Push down on the brightwork to secure it.

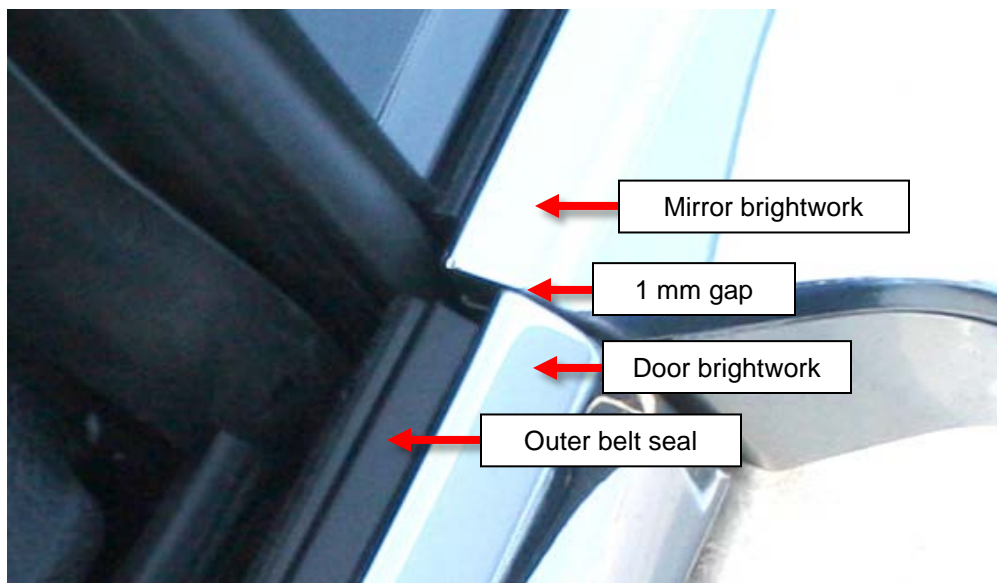
Figure 10

NOTE: Moving the outer belt seal forward might create a gap between the front and rear door brightwork.

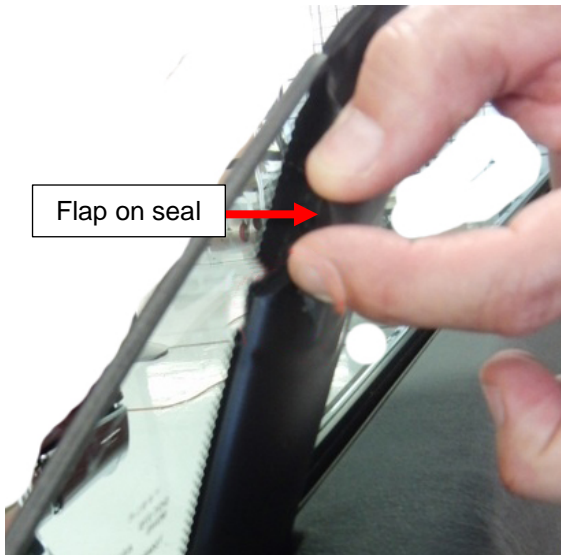
Figure 11

Seal Between Fixed and Moving Glass Not Secure

Desired condition: The seal on the division bar is secured to the fixed glass.

1. From inside the vehicle, inspect the seal. If there is a loose flap (Figure 11), use super glue (Figure 12) to secure it to the fixed glass.

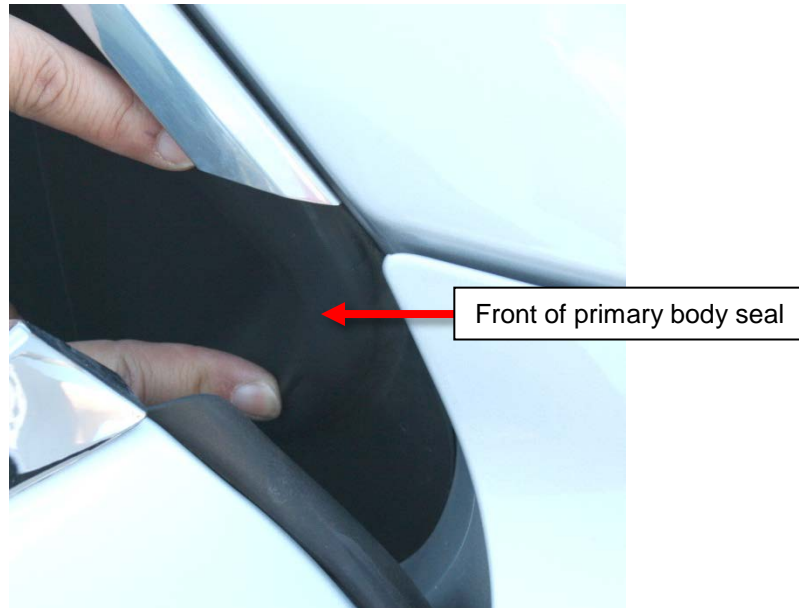
Figure 14

Inadequate Stuffer at Front of Primary Seal

Desired condition: The stuffer at the front of the primary body seal does not yield easily under pressure (Figure 14).

1. Cut a 50 mm length of rubber hose (1028376-00-A).
2. Carefully peel back the front of the primary body seal.

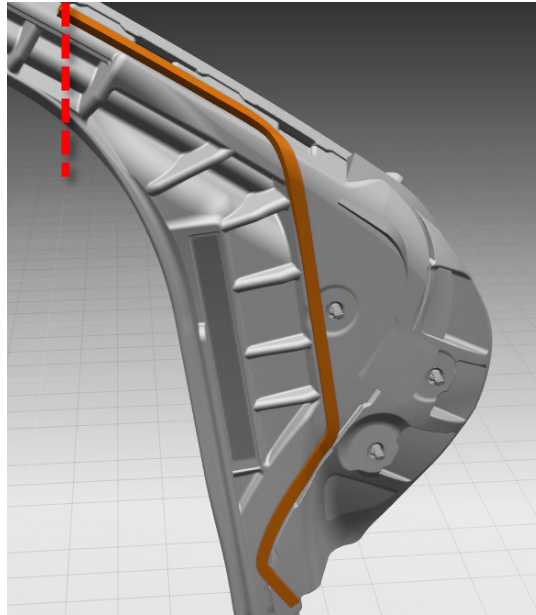
Figure 17

Missing Foam Behind Primary Body Seal

Desired condition: The foam on the inside of the primary body seal extends to the top front corner of the seal (Figure 17).

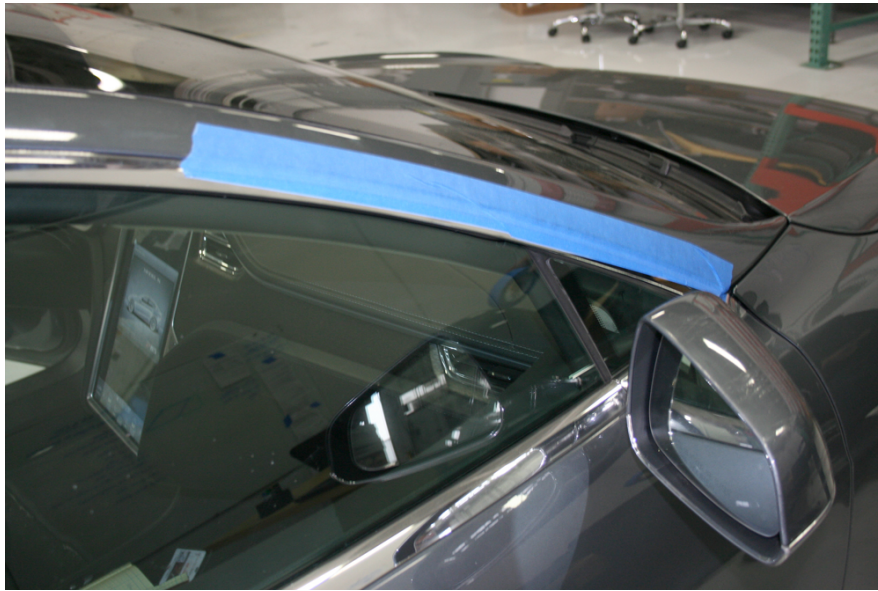
Figure 19

Gap Between Body and Front of Brightwork

Desired condition: There is no gap between the brightwork and the body underneath the primary body seal.

Inspection/Correction: To test for this condition, cover the outside of the brightwork with tape (Figure 19) and drive the vehicle.

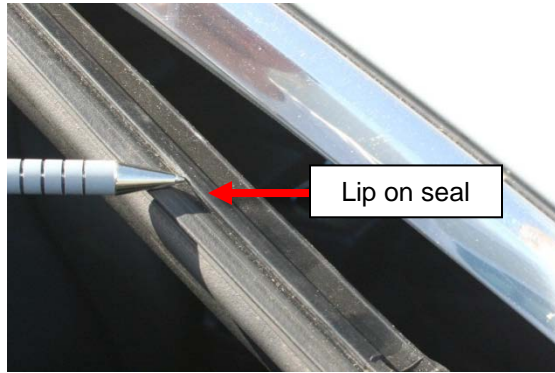
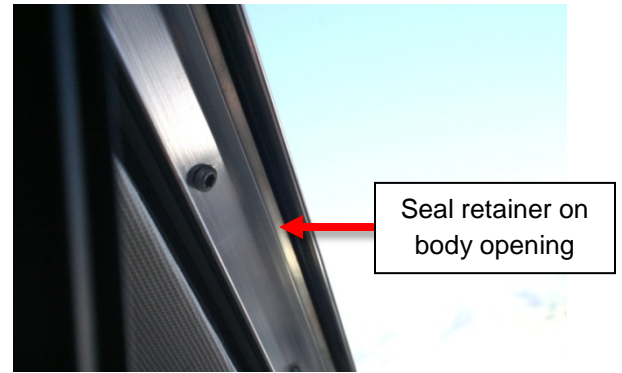
Primary Body Seal Not Secure

Desired condition: The primary body seal is secure to the brightwork.

1. Pull the seal out of the brightwork.
2. Locate the lip on the seal (Figure 22) and the seal retainer on the body opening (Figure 23).

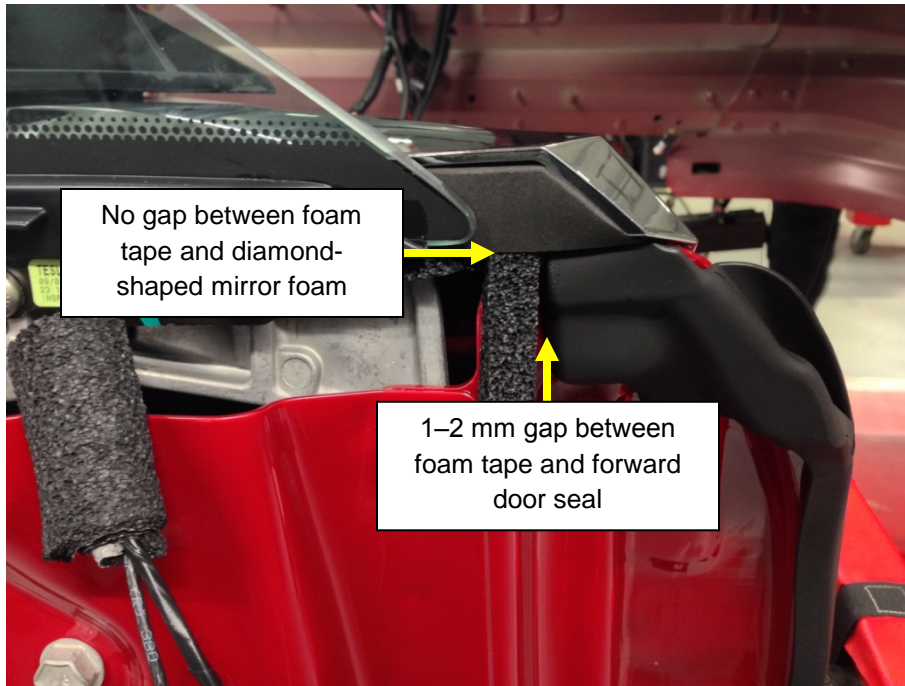
Figure 26

Missing Foam Tape Beneath Front Door Seal

Desired condition: There is a piece of foam beneath the front door seal (Figure 26).

2. If necessary, cut a piece of foam tape (1007167-00-B), 50 mm x 12 mm x 10 mm.
3. Affix the foam tape to the door as shown (Figure 26); ensure that the foam is flush with the diamond-shaped mirror foam in front of the fixed glass, and that there is a 1–2 mm gap between the foam and the forward door seal.

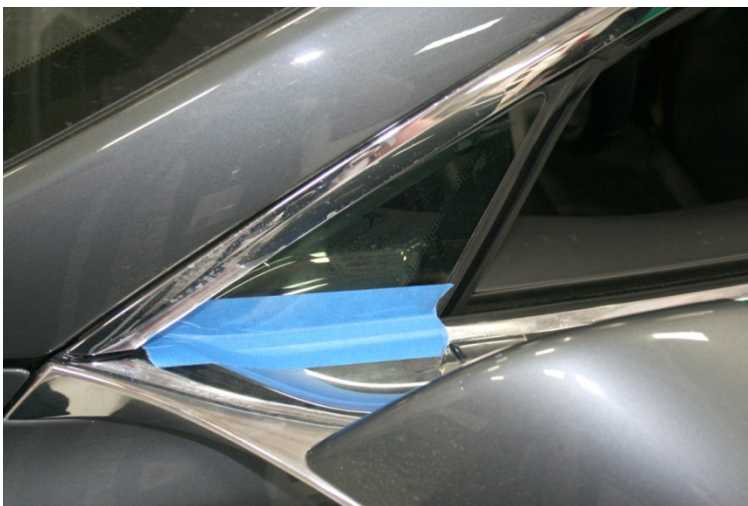
Figure 29

Missing Sealant Between Mirror and Fixed Glass

Desired condition: There is a solid seal between the mirror and the front fixed glass.

NOTE: These vehicles were built with mirrors that did not have a seal between the mirror and the fixed glass.

2. Drive the vehicle with a piece of tape over the seam between the mirror and the fixed glass (Figure 29).

3. If the previous step stops the wind noise, apply 3M sealant along the seam and use a trim stick or similar tool to push the applied sealant into the seam.
4. Clear away the excess sealant with an IPA wipe. This leaves a nearly invisible layer of sealant inside the seam.

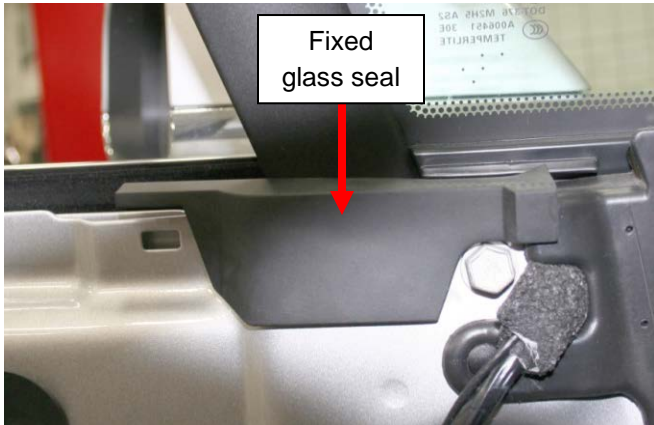
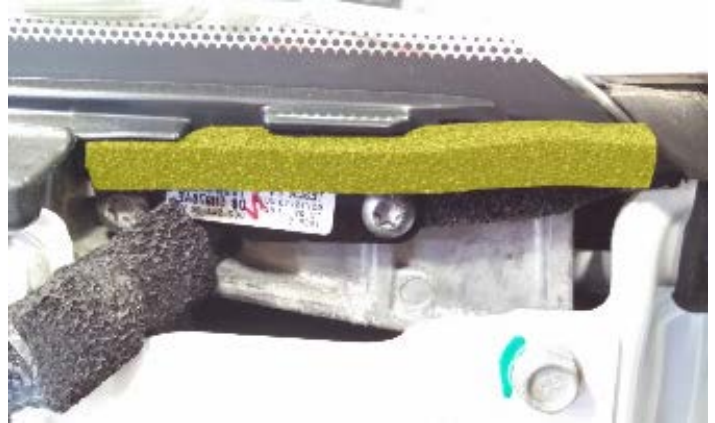
Missing Fixed Glass Seals and Foam Strips Under Fixed Glass

Desired condition: There are fixed glass seals and horizontal foam strips under the fixed glass on both sides of the vehicle (Figures 30 and 31).

Inspection/Correction: Determine whether SB-15-11-002, "Cold Draft or Wind Noise Coming From Fixed Glass" is applicable to the vehicle. If so, perform the bulletin.
