Model: Model S

Tech Note: Loose Rivnuts in Sill

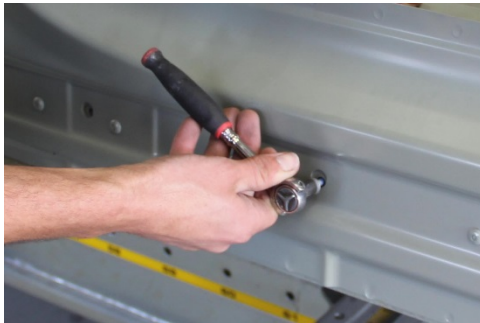
Figure 1

Tesla uses Rivnuts (internally-threaded rivet nuts) in the sill of Model S to provide fastening points for the bolts that secure the rocker trim. These Rivnuts can come loose during repair, especially if an impact gun is used to remove or install the bolts that secure the rocker trim.

⚠ CAUTION: Use only conventional wrenches to remove or install a bolt that goes into a Rivnut (Figure 1). Do not use impact guns on these bolts (Figure 2).
