C-Pillar Brightwork Creaking

Classification	Repair Bulletin	Section/Group	12 - Exterior Fittings	Country/Region	United States, Canada, Europe
Year	2012-2013	Model	Model S	Version	All

This Service Bulletin supersedes SB-13-12-004 R3, dated 6-Jan-13. Each content change is marked by a vertical line in the left margin. Discard the previous version and replace it with this one.

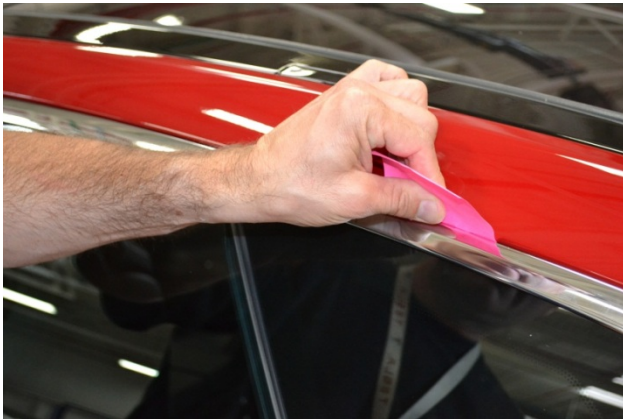
Figure 1

1. On both sides of the vehicle, slide a piece of paper in the gap between the top of the brightwork and the body, beginning at the front of the rear quarter glass and moving towards the rear of the vehicle (Figure 1). When the piece of paper can no longer move freely in this gap and can stand in place by itself, leave the paper there. This is the front of the affected area.

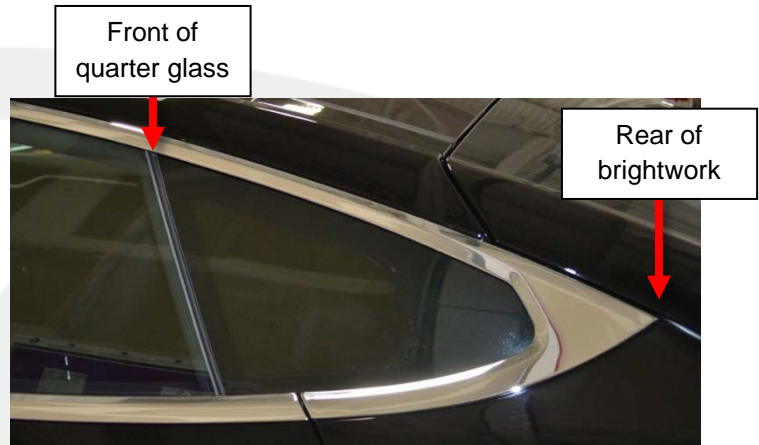
Figure 2

NOTE: If the paper slides all the way from the front of the rear quarter glass to the rear of the brightwork (Figure 2), then no work is required on that side of the vehicle.

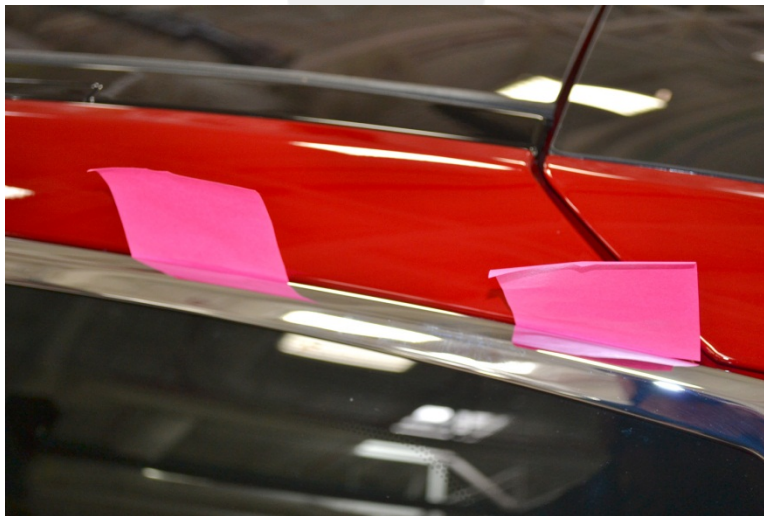
Figure 3

2. Repeat step 1 with another piece of paper, beginning at the rear of the brightwork and moving towards the front of the vehicle. When the piece of paper can no longer move freely in the gap between the top of the brightwork and the body, and can stand in place by itself, leave the paper there (Figure 3). This is the rear of the affected area.
