Defrost Mesh Grille Update

Classification	Repair Bulletin	Section/Group	14 - Instrument Panel & Pedals	Country/Region	United States
Year	2012-2013	Model	Model S	Version	All

This Service Bulletin supersedes SB-13-14-001 R3, dated 22-Jan-2014. Each content change is marked by a vertical line in the left margin. Discard the previous version and replace it with this one.

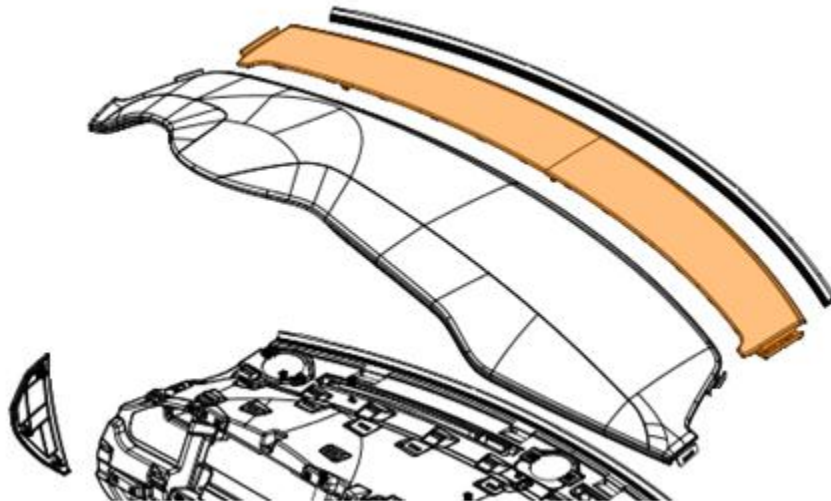
Figure 1

An updated defrost mesh grille is available. The original design meets all federal standards for defrosting the windshield promptly, but the updated grille improves windshield clearing performance in the edges near the LH and RH A-Pillars.

Upon customer complaint, replace the defrost mesh grille with the updated part (Figure 1).

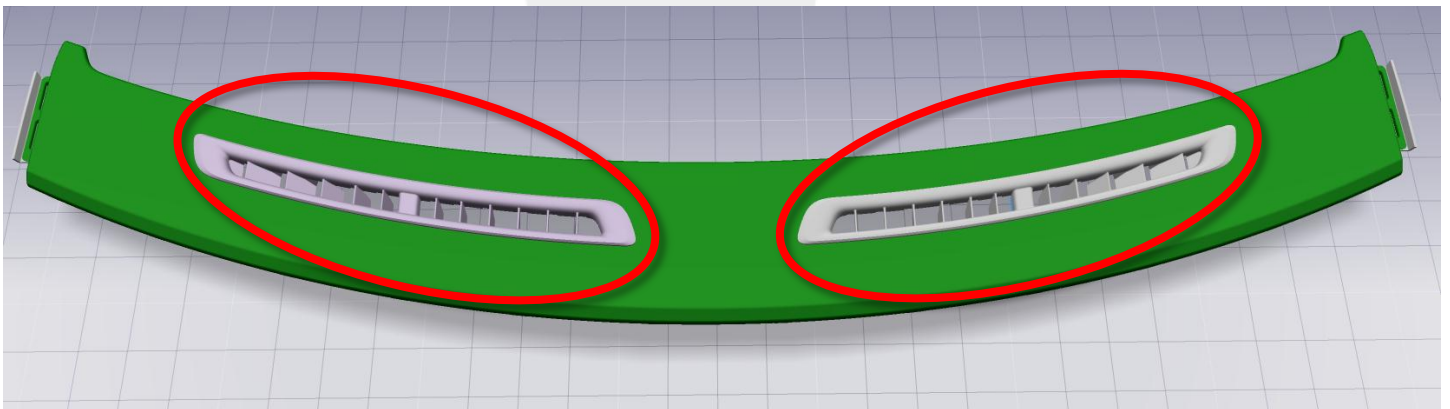
Figure 2

1. Inspect the defrost mesh grille that is inside the vehicle. If the grille has vents that direct air toward the A-Pillars (Figure 2), then the new grille is already installed and no more work is needed.
