Brake Rotor Update to Reduce Noise

Classification Repair Bulletin **Section/Group** 33 - Brakes **Country/Region** All

Year All **Model** Model S **Version** All

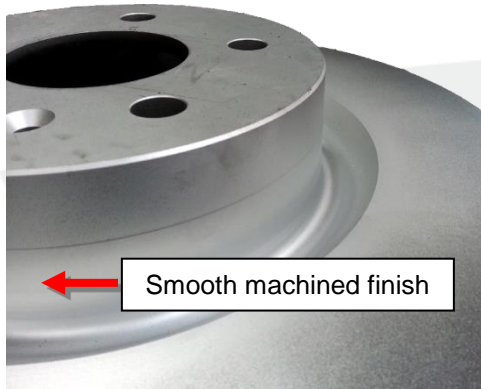
1. Check the design of the front rotors by looking through the openings in one of the front wheels. The standard front rotors have a smooth, machined finish on the hat (Figure 1). The service rotors have a rough, as-cast finish on the hat (Figure 2). Continue this procedure if the standard front rotors are installed.

Figure 1 (Machined front rotor)

Upon customer complaint, install updated service front rotors. Do not replace the brake pads unless they are near the minimum allowable thickness (2 mm).

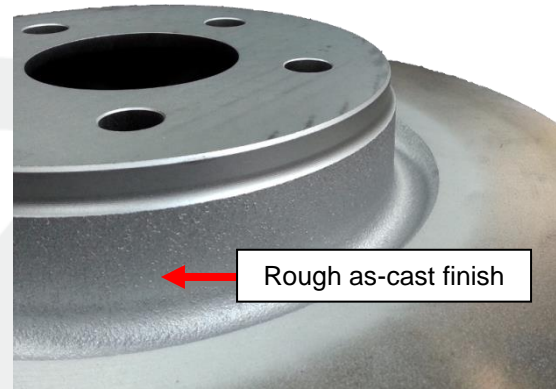
Figure 2 (As-cast front rotor)

4. Install 2 front rotors with as-cast outer hats.
5. Test drive the vehicle, making several light to moderate stops to check for proper brake operation. No special bed-in process is required unless the brake pads were replaced.
