HVIL Connector Upgrade

Classification	Repair Bulletin	Section/Group	44 - High Voltage System	Country/Region	North America, Europe
Year	2012-2013	Model	Model S	Version	All

This Service Bulletin supersedes SB-13-44-003 R1, dated 29-May-13. Each content change is marked by a vertical line in the left margin. Discard the previous version and replace it with this one.

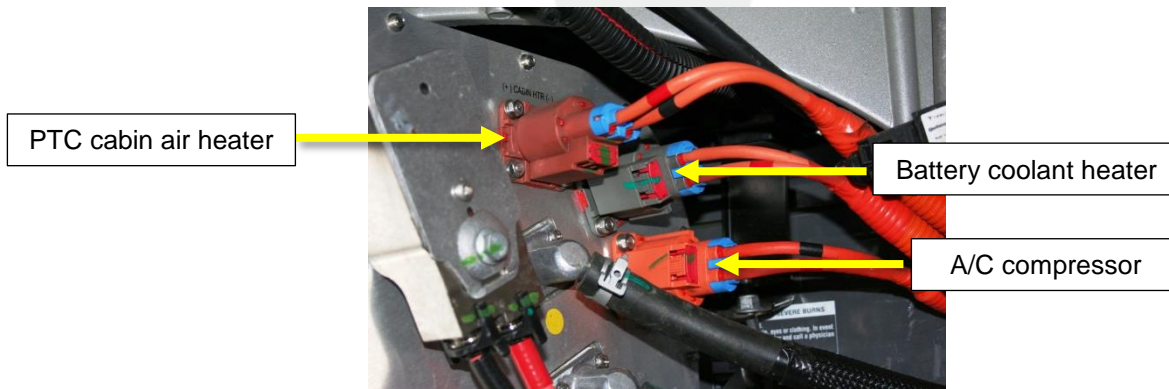
Figure 3

4. The DCDC Converter is mounted on the RHF side fender well. Locate the PTC cabin air heater, battery coolant heater, and A/C compressor connectors on the DCDC converter (Figure 3).
