Second Generation Charger Logic Reset

Classification	Campaign Bulletin	Section/Group	44 - High Voltage System	Country/Region	Europe
Year	2013	Model	Model S	Version	All

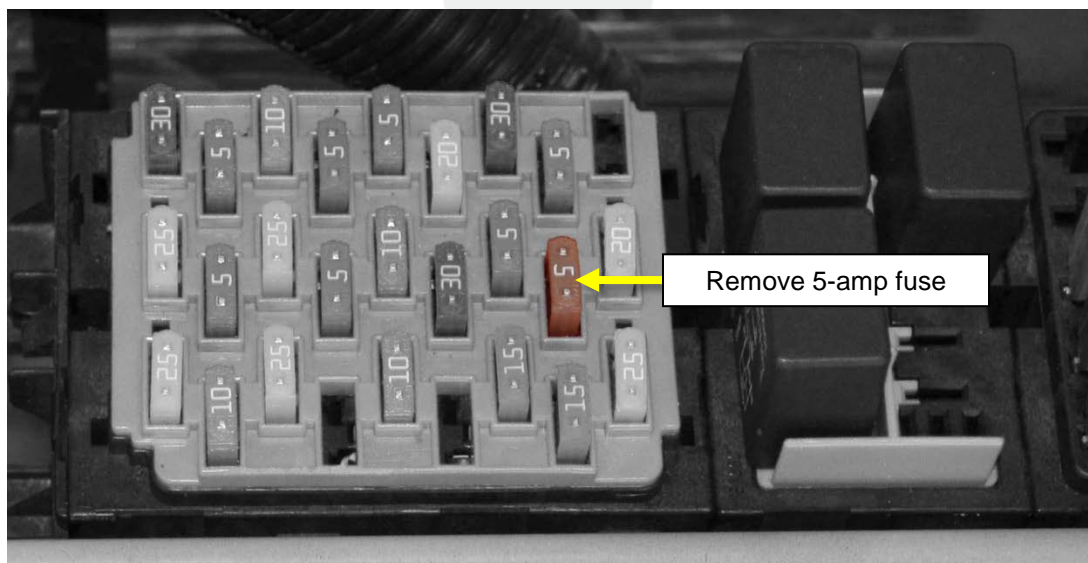
Figure 2

NOTE: This fuse protects the master charger, charge port, and slave charger, if equipped.

6. Remove the 5-amp F44 fuse as shown (Figure 2).
