First Generation Front Fascia Applique Replacement

Classification	Repair Bulletin	Section/Group	10 - Body	Country/Region	North America
Year	2012	Model	Model S	Version	All

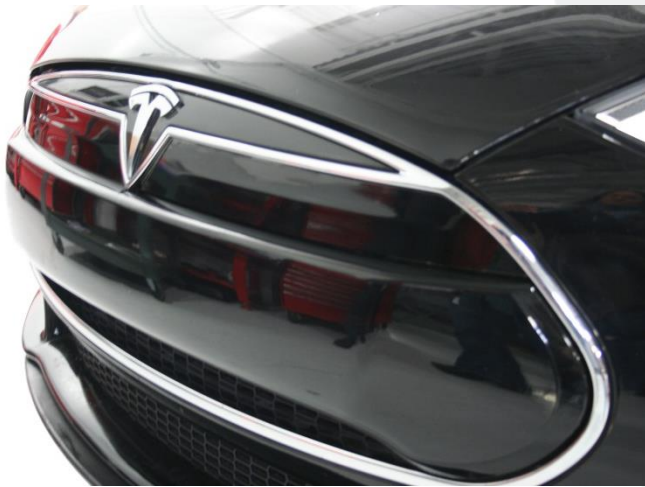
Figure 1 (1st generation)

Early Model S vehicles were equipped with the 1st generation front fascia applique (nosecone) that had a horizontal ridge across the front (Figure 1). This style of nosecone is no longer in production and must be replaced with the smooth, 2nd generation nosecone (Figure 2) after a front collision or if the applique needs to be replaced for another reason.

Remove the 1st generation nosecone and associated parts and replace with the 2nd generation nosecone and associated parts. Ensure the airbag module firmware has the latest version.
