Second Generation Active Louver Retrofit

Classification	Repair Bulletin	Section/Group	17 - Electrical	Country/Region	North America
Year	2012 - 2013	Model	Model S	Version	All

This Service Bulletin supersedes SB-14-17-004 R2, dated 8-Oct-14. Each content change is marked by a vertical line in the left margin. Discard the previous version and replace it with this one.

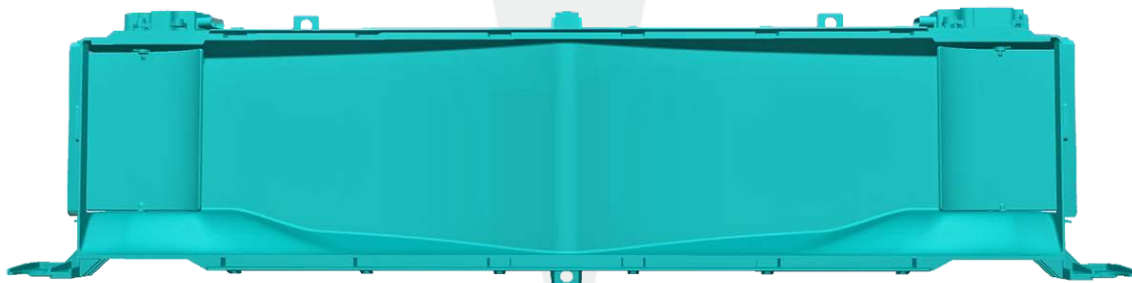
The 1st generation active louvers (Figure 1) are no longer available.

Figure 1 (1st Generation active louver)

After a collision or another scenario where the active louver need to be replaced, retrofit the 2nd generation active louver assembly (Figure 2) and associated parts onto the vehicle. Refer to the Required Parts table.

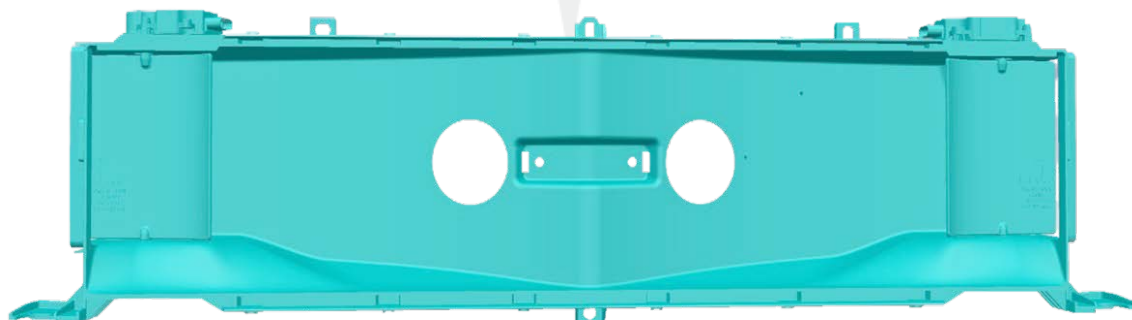
Figure 2 (2nd Generation active louver)

NOTE: The horns are mounted in the middle of the 2nd generation active louver. When retrofitting the 2nd generation active louver, it is also necessary to relocate the horns.

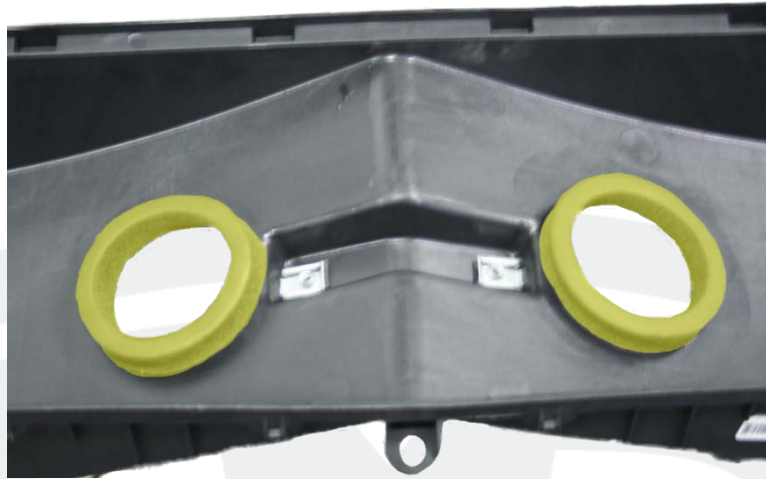
Figure 5 (Large gaskets highlighted)

5. Remove the backing material from the large gaskets and adhere them to the front of the active louver around the circular cutouts (Figure 5).

NOTE: Ensure that the gaskets follow the contour of the circular cutouts so that they do not interfere with the installation of the horns.

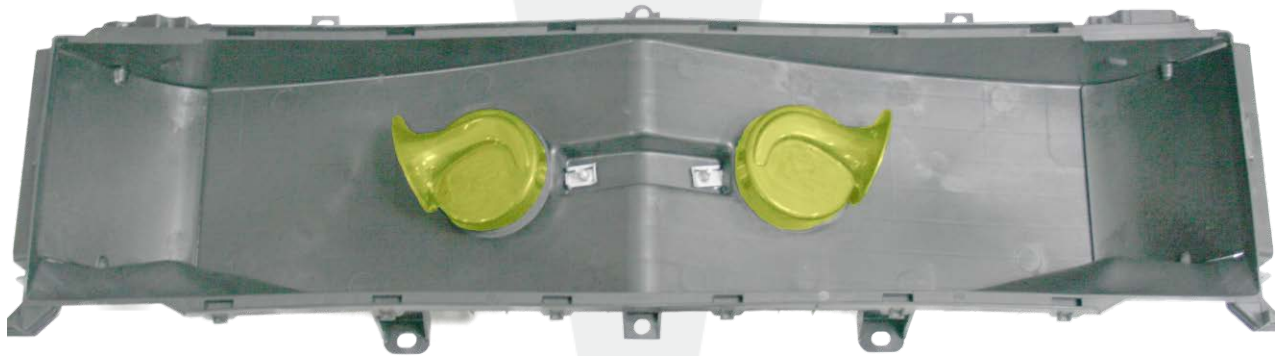
Figure 6 (Horns highlighted)

6. From the front of the active louver, insert each horn and bracket through the appropriate cutout (Figure 6).

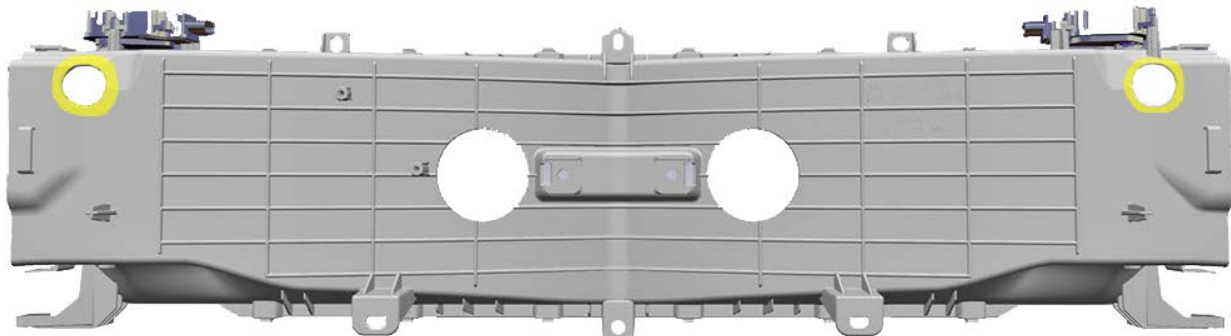
Figure 8 (Outer circular cutouts highlighted)

8. If the active louver is revision K or newer, remove the backing material from the small gaskets and adhere them to the rear of the active louver around the 2 outer circular cutouts (Figure 8). If the louver is revision H-J, discard the small gaskets.

NOTE: Ensure that the gaskets follow the contour of the circular cutouts.
