# Replace PSRCM

<b>Classification</b>	Campaign Bulletin	<b>Section/Group</b>	17 - Electrical	<b>Country/Region</b>	North America
<b>Year</b>	2014	<b>Model</b>	Model S	<b>Version</b>	All

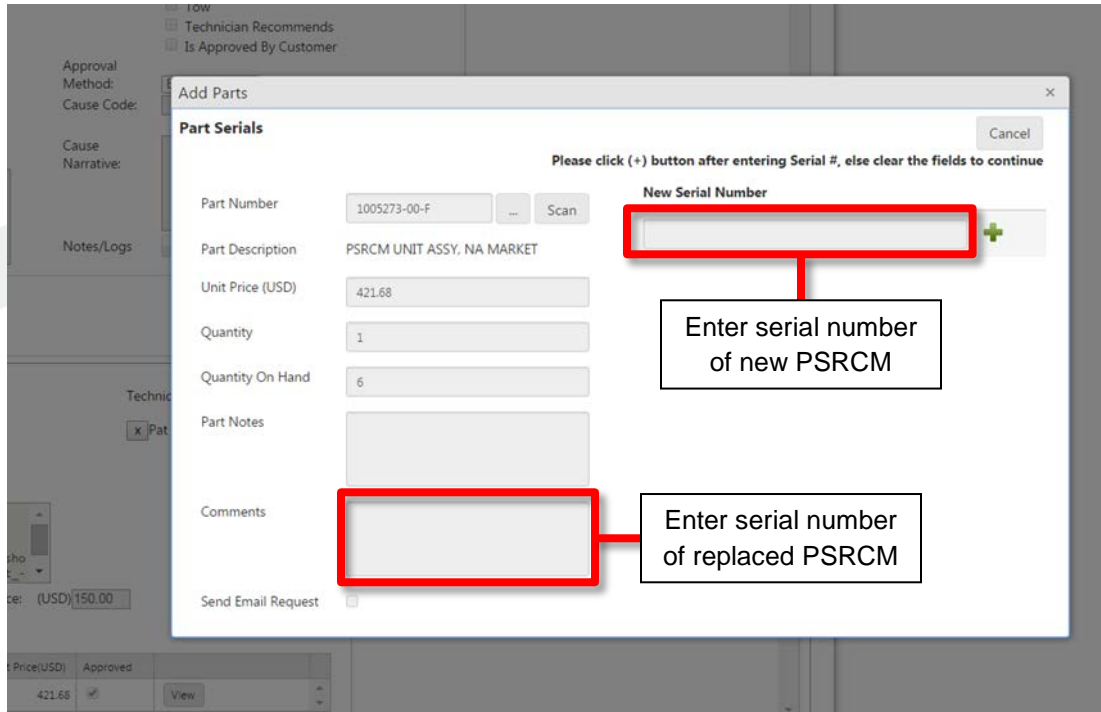
Figure 1

**NOTE:** In the “Part Serials” window in the Repair Order, enter the serial number of the new PSRCM in the “New Serial Number” field, and then enter the serial number of the replaced PSRCM in the “Comments” field (Figure 1).

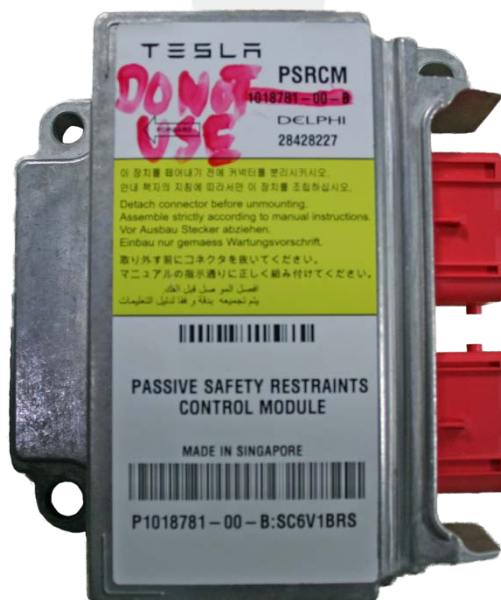
Figure 2

2. At the top of the label on the replaced PSRCM, cross out the part number and write “DO NOT USE” in red ink (Figure 2).
