Panoramic Roof Track Adjustment

Classification	Repair Bulletin	Section/Group	24 - Roof	Country/Region	All
Year	2013-2014	Model	Model S	Version	Panoramic Roof

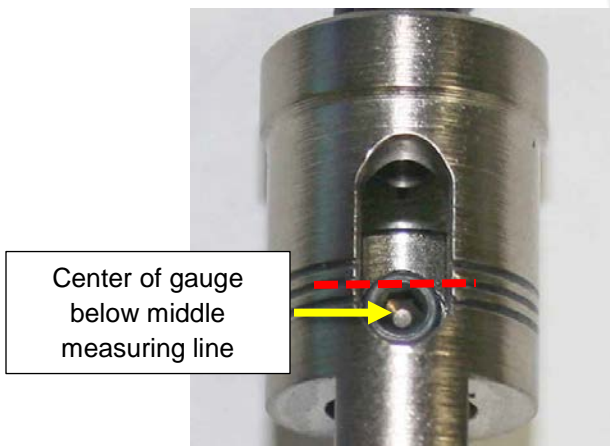
Figure 4

7. Inspect the gauge on the side of the tool body:
 - If the center of the gauge is below the middle measuring line (Figure 4), the track does not need to be adjusted. Discontinue work on this side of the vehicle.
 - If the center of the gauge is above the middle measuring line (Figure 5), continue to the next step in this procedure.
