# Steering Rack Water Ingress, Norway

**Classification** Campaign Bulletin    **Section/Group** 32 - Steering    **Country/Region** Norway

**Year** 2013-2014    **Model** Model S    **Version** RWD

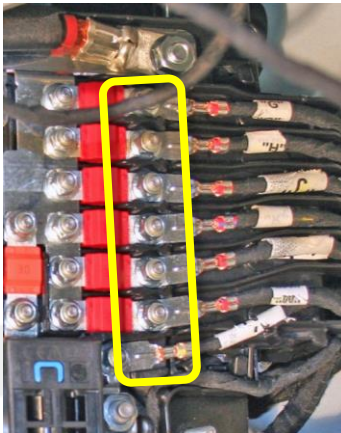
**Figure 1**

3. Release the 6 nuts that attach the 12V harness cables to the 12V battery fusebox (torque 5 Nm) (Figure 1).

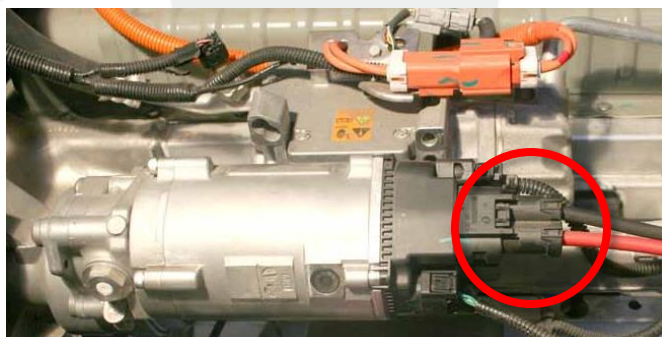
**Figure 2**

4. Disconnect the EPAS cable assembly from the steering rack (Figure 2).

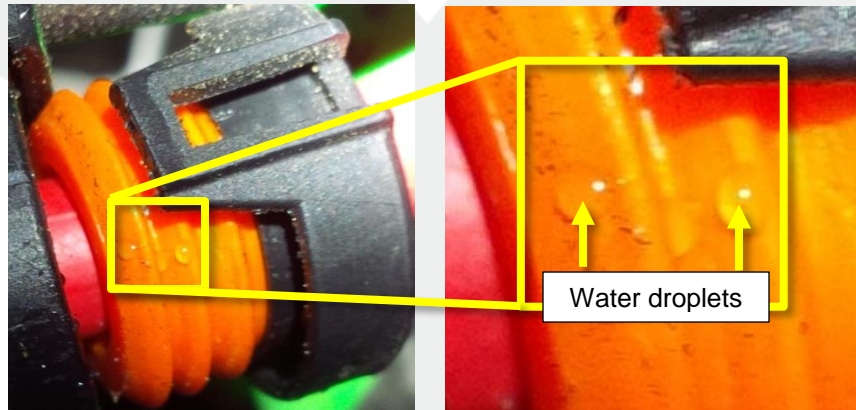
**Figure 4**

5. Thoroughly inspect the connector for evidence of water ingress.
  - a. Inspect both the male and female ends of the connection.
  - b. Remove the cover from the housing on the red positive cable (Figure 3) and inspect inside the housing.

- c. Inspect the orange gasket (Figure 4).

6. If there is no evidence of water ingress, continue to the “Apply Heat Shrink Tubing to Harness” section. If there is evidence of water ingress, skip to the “Replace Steering Rack and Harnesses” section.

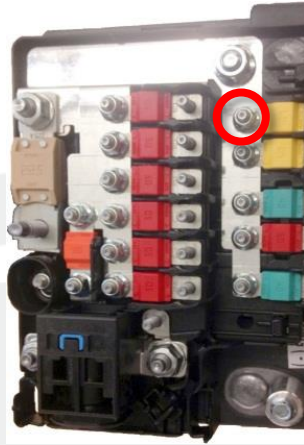
Figure 5

1. Remove the wire separator to expose the bottom layer of harnesses.
2. Release the nut that attaches the positive power steering harness to the 12V fusebox (torque 5 Nm) (Figure 5).

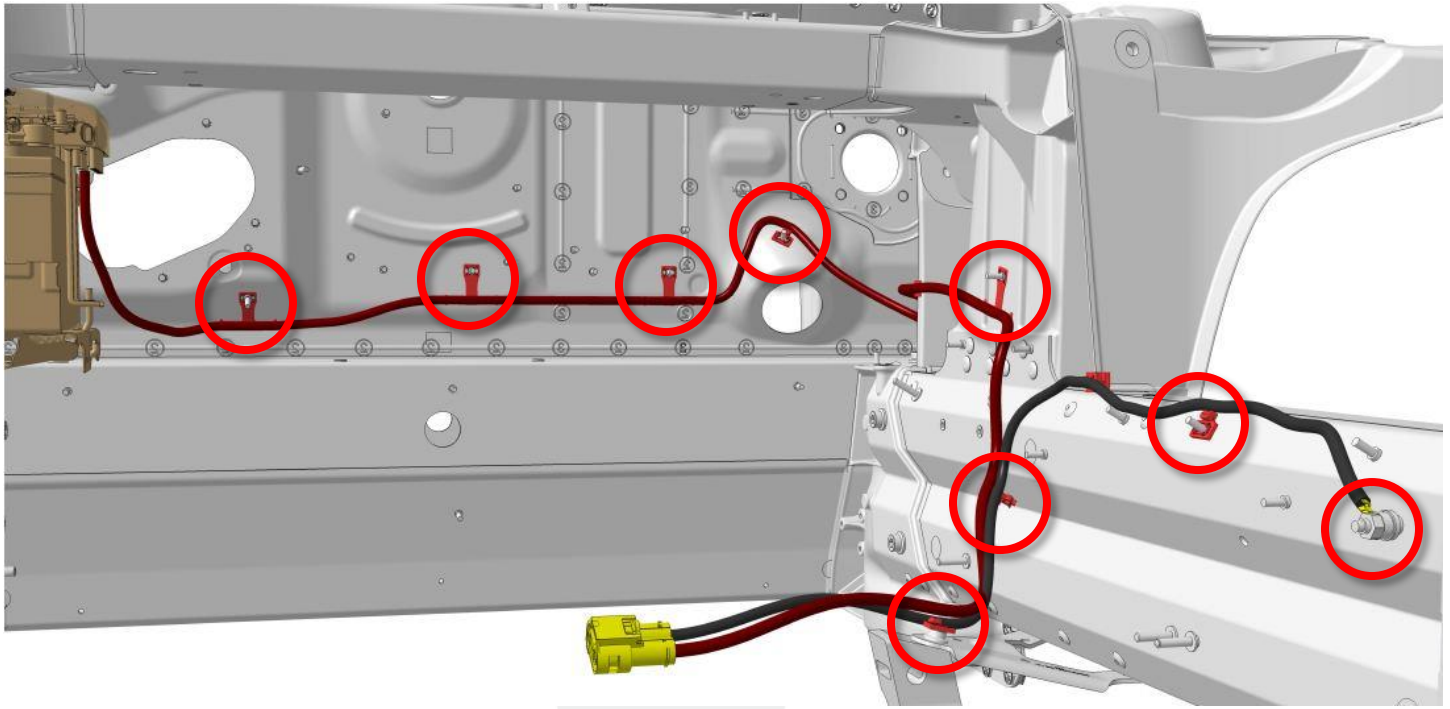
**Figure 8 (Location of harness mounting points shown)**

1. Remove and discard the front left side body harness (refer to Service Manual procedure 17103002).
2. Remove and discard the power steering harness (Figure 8).

3. Replace the steering rack (refer to Service Manual procedure 32010102).
4. Install the new power steering harness.
5. Install the new front left side body harness.
6. Reinstall all components that were removed for access.
7. Perform a four wheel alignment (refer to Service Manual procedure 31000100).
8. Test drive the vehicle to ensure that there are no alerts.
