# Reroute Power Steering Harness

<b>Classification</b>	Campaign Bulletin	<b>Section/Group</b>	17 - Electrical	<b>Country/Region</b>	United States, Canada
<b>Year</b>	2014-2015	<b>Model</b>	Model S	<b>Version</b>	Dual Motor

*This Service Bulletin supersedes SB-15-17-001, dated 5-Feb-14. Each content change is marked by a vertical line in the left margin. Discard the previous version and replace it with this one.*

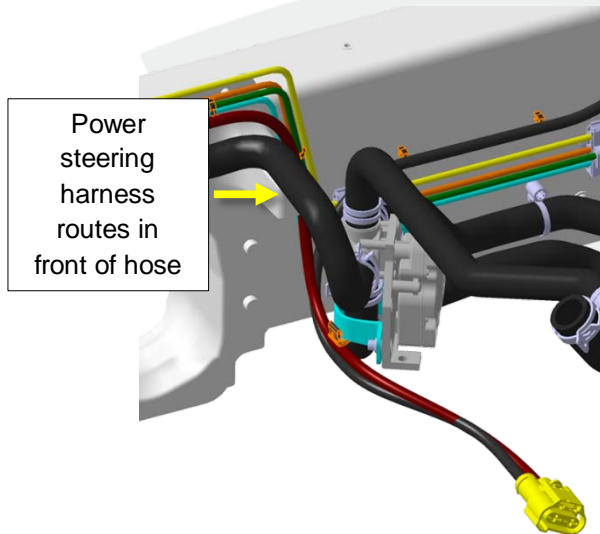
✓ Figure 1

- If the power steering harness routes in front of or next to the hose (Figure 1), skip to the “Inspect Clips and Ties” section of this document.
- If the power steering harness routes behind the hose (Figure 2), continue this procedure to reroute it.

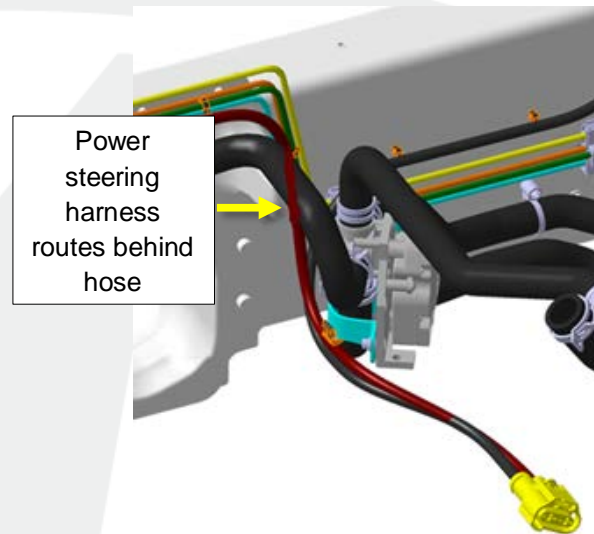
✗ Figure 2

On some vehicles, the LH halfshaft might contact the power steering harness. This might result in an alert message on the instrument cluster.
