## Re-Torque Ground Nut on Front LH Rail

<b>Classification</b>	Campaign Bulletin	<b>Section/Group</b>	17 - Electrical	<b>Country/Region</b>	Europe, Asia Pacific
<b>Year</b>	2015	<b>Model</b>	Model S	<b>Version</b>	RHD

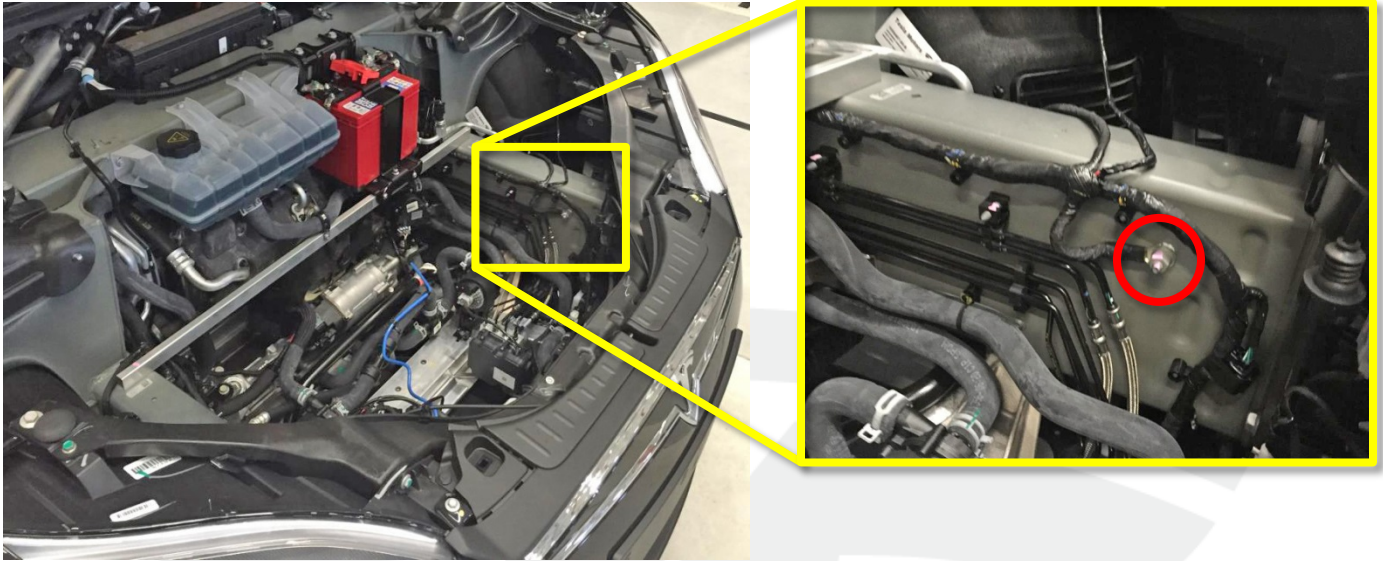
Figure 1

On some right hand drive (RHD) Model S vehicles, the nut that secures the ground on the front LH rail might not be fully torqued, which can cause warning messages to appear on the instrument cluster.

2. Fully torque the ground nut (torque 9 Nm) (Figure 1). Ensure that the nut cannot be loosened by hand.
