Upgrade Right Side Front Motor Mount

Classification	Campaign Bulletin	Section/Group	39 - Front Drive Unit	Country/Region	All
Year	2014-2015	Model	Model S	Version	Dual Motor

This Service Bulletin supersedes SB-15-39-001 R1, dated 23-Mar-15. Each content change is marked by a vertical line in the left margin. Discard the previous version and replace it with this one.

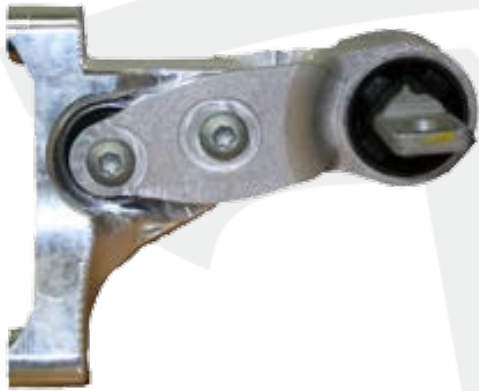
Figure 1

- If the LH mount consists of 2 pieces bolted together (Figure 1), replace the RH motor mount (refer to Service Manual procedure 39012402).

NOTE: Follow all steps in the procedure; adjusting the LH mount is a step in replacing the RH mount.

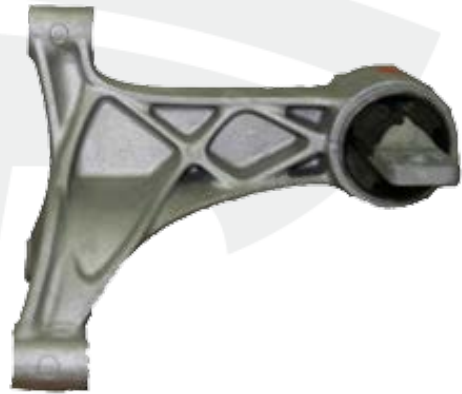
Figure 2

- If the LH mount consists of a single, cast piece (Figure 2), replace both the RH and LH motor mounts (refer to Service Manual procedures 39012402 and 39012602).

NOTE: Replace the bolts that secure the mount to the body and add washers.
