Replace Motorized Charge Port

Classification	Campaign Bulletin	Section/Group	44 - High Voltage System	Country/Region	United States, Canada
Year	2014-2015	Model	Model S	Version	Dual Motor

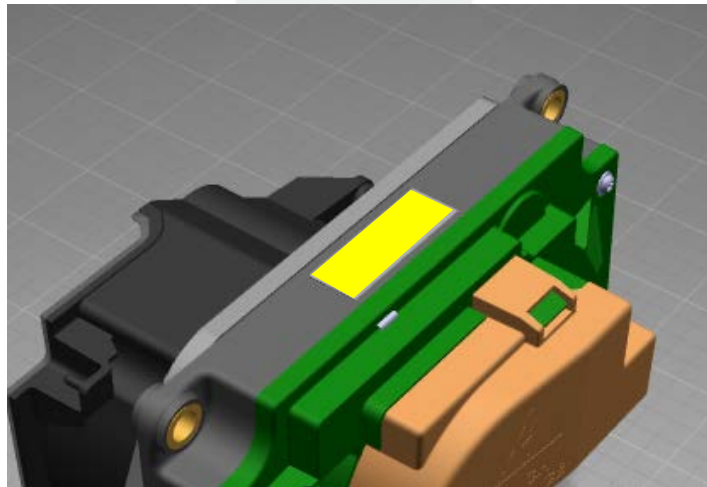
1. Remove the LH rear trunk trim (refer to Service Manual procedure 15245002).
2. Use a borescope to identify the revision level on the part number label at the top of the charge port (Figure 1).
 - If the revision is 1026041-00-H or later, reinstall the parts removed for access. No additional work is needed; reinstall the rear trunk trim and discontinue this procedure.
 - If the revision is 1026041-00-G or earlier, continue this procedure.

Figure 1 (Part number label highlighted)
