Upgrade HV Inlet Cover

Classification	Campaign Bulletin	Section/Group	44 - High Voltage System	Country/Region	United States, Canada
Year	2014-2015	Model	Model S	Version	Dual Motor

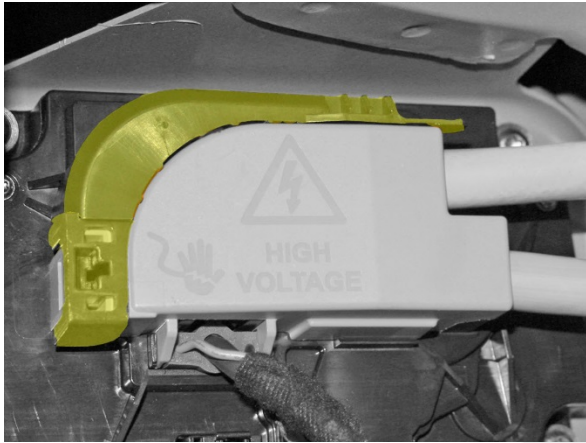
Figure 1 (Locking piece highlighted)

1. Remove the charge port cover trim.
2. Inspect the HV inlet cover:
 - If the top of the cover has a curved locking piece (Figure 1), the correct cover is already installed. Reinstall all components and reconnect electrical power.
 - If the cover has a red locking tab (Figure 2), continue this procedure.

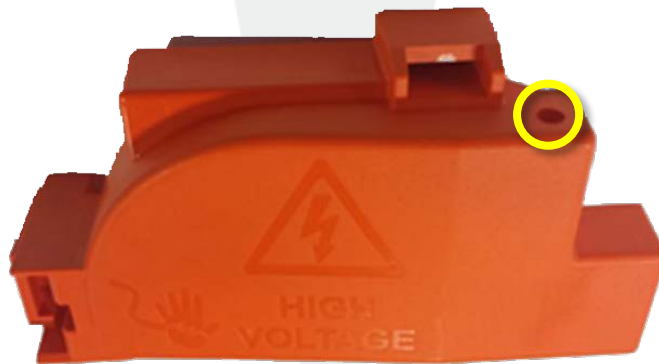
Figure 3

3. Ensure that the upgraded HV inlet cover has a hole as shown (Figure 3). Do not install a new cover if it does not have this hole.
