Install Underhood Acoustic Absorbers

Classification	Campaign Bulletin	Section/Group	45 - Noise, Vibration & Harshness	Country/Region	All
Year	2014-2015	Model	Model S	Version	Dual Motor

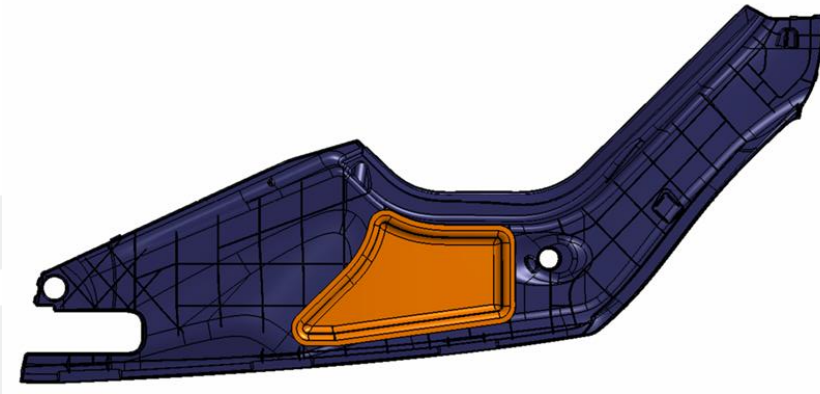
Figure 1 (acoustic absorber highlighted)

1. Remove the LH underhood apron (refer to Service Manual procedure 12251202).
2. Inspect the apron for an acoustic absorber (Figure 1).

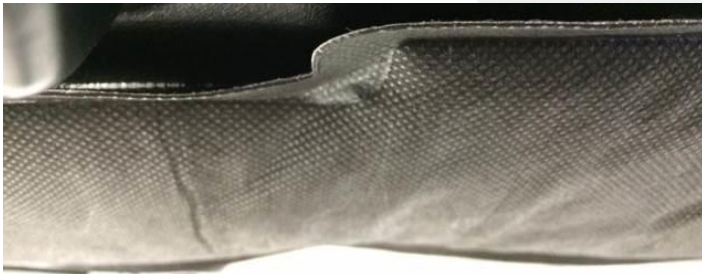
Figure 2

- If there is an acoustic absorber on the apron and the edges are sealed (Figure 2), reinstall the LH underhood apron and discontinue this procedure; no additional work is required.
- If there is no acoustic absorber on the apron or if the edges are unsealed (Figure 3), continue this procedure.
