Add Washers to Mid Aero Shield and Rear Diffuser Fasteners

Classification	Campaign Bulletin	Section/Group	12 - Exterior Fittings	Country/Region	United States
Year	2016	Model	Model X	Version	All

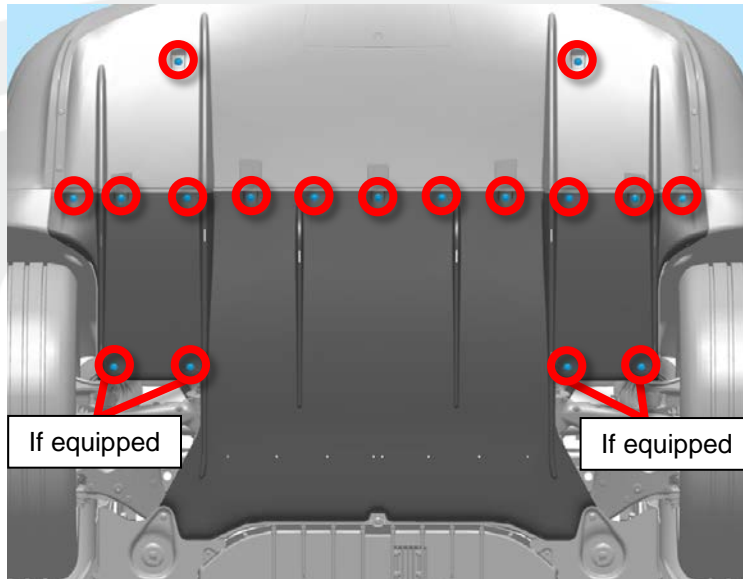
Figure 1

Some Model X vehicles were built without washers on the fasteners that secure the mid aero shield and rear diffuser. This could allow the mid aero shield or rear diffuser to become detached from the vehicle in extreme driving conditions.

NOTE: On some early Model X vehicles, the mid aero shield is not equipped with the 4 forward fasteners shown.

2. Inspect the mid aero shield and rear diffuser for washers on the fasteners shown (Figure 1).

- If all fasteners have washers, no additional work is required. Lower the vehicle and discontinue this procedure.
- If any of the fasteners are missing a washer, remove the fastener and reinstall it with a washer (torque 4 Nm).
