Replace Sun Visors Due To Splitting

Classification	Campaign Bulletin	Section/Group	15 - Interior Trim	Country/Region	United States
Year	2016	Model	Model X	Version	All

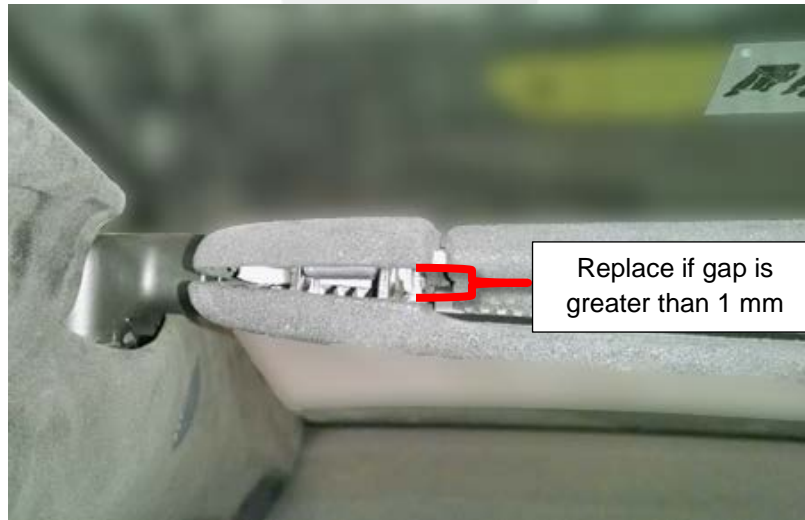
Figure 1

1. Inspect the bottom of the LH sun visor (Figure 1). If any section along the bottom of the sun visor has a gap that is greater than 1 mm, replace the sun visor (refer to Service Manual procedure 15051002).

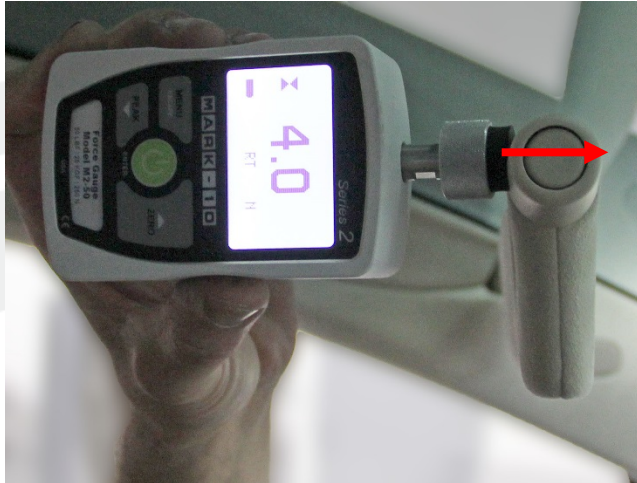
Figure 2

2. Position the sun visor halfway between the A-Pillar and the rear view mirror.
3. Using a force gauge on the plastic cap on the sun visor, rotate the sun visor toward the rearview mirror (Figure 2). If the force required to move the visor at any point in its rotation is 9 N or greater, replace the sun visor (refer to Service Manual procedure 15051002).

NOTE: While rotating, ensure that the sun visor is vertical to prevent an inaccurately high force reading.
