# Replace Key Batteries and Update Key Firmware

**Classification** Campaign Bulletin    **Section/Group** 17 - Electrical    **Country/Region** United States

**Year** 2016    **Model** Model X    **Version** All

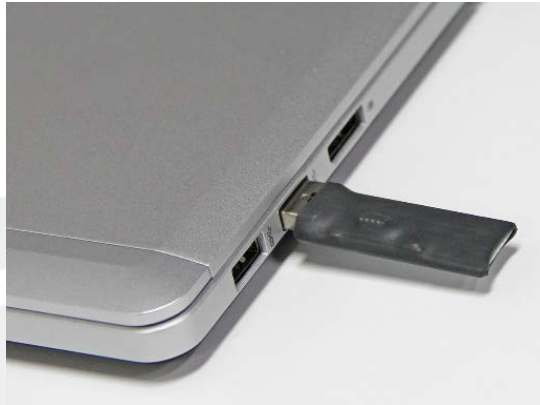
**Figure 1**

3. Connect the laptop to the vehicle.
4. Insert the BLE dongle into the laptop's USB port (Figure 1).

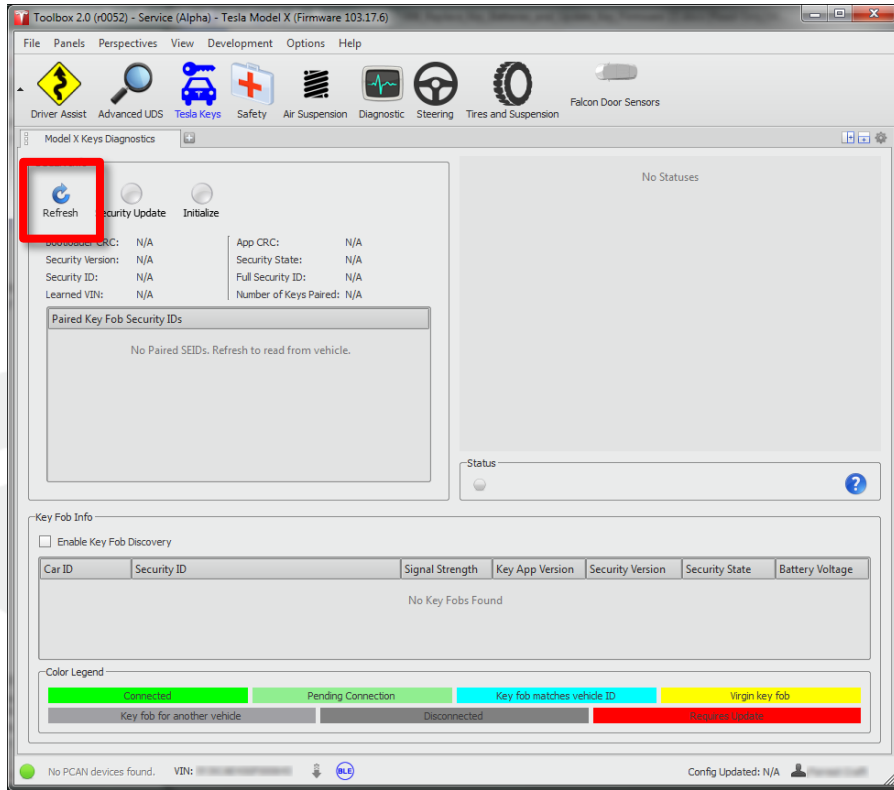
Figure 2

6. In the “BCCEN Info” field, click the **Refresh** icon (Figure 2).

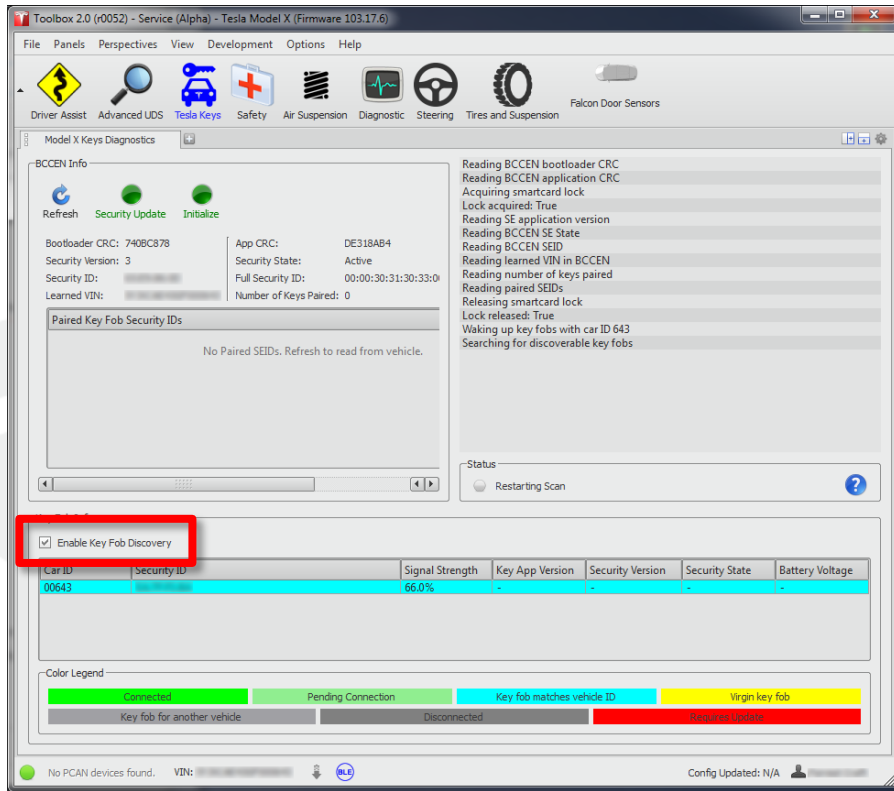
Figure 3

8. Click the **Enable Key Fob Discovery** checkbox (Figure 3).

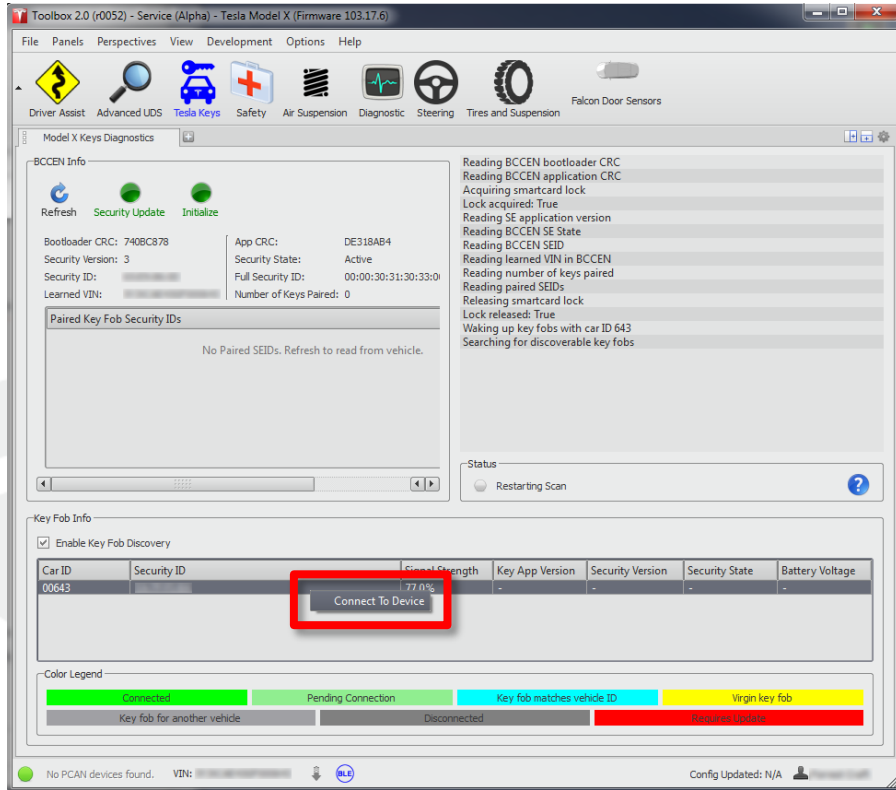
Figure 4

9. Right click the first key and select **Connect To Device** (Figure 4).

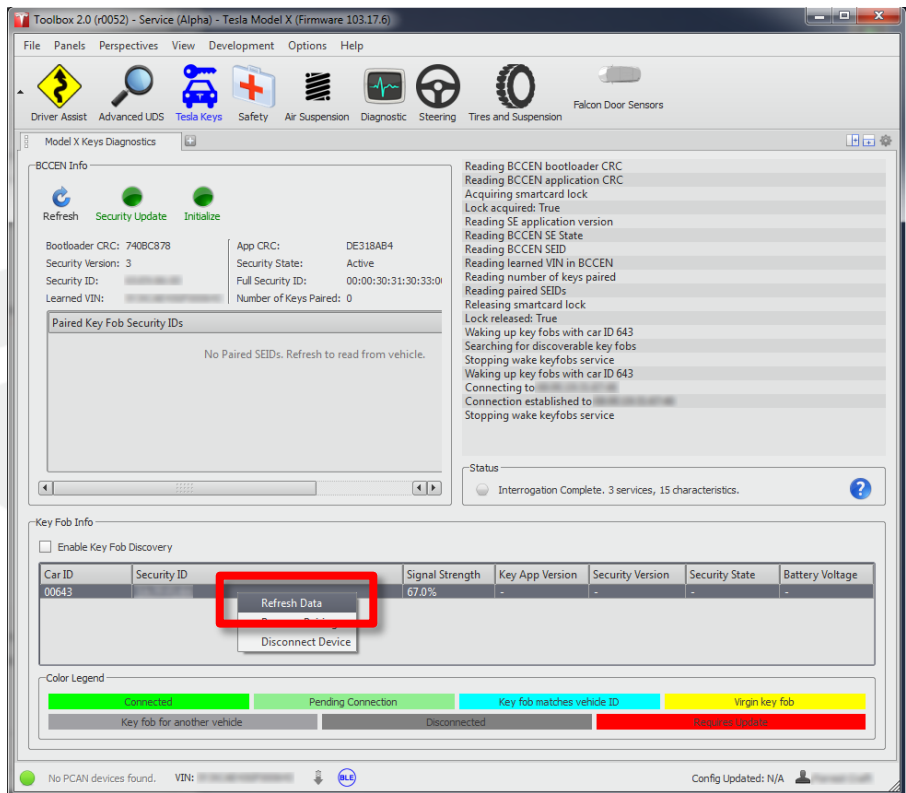
Figure 5

10. Right click the key and select **Refresh Data** (Figure 5).

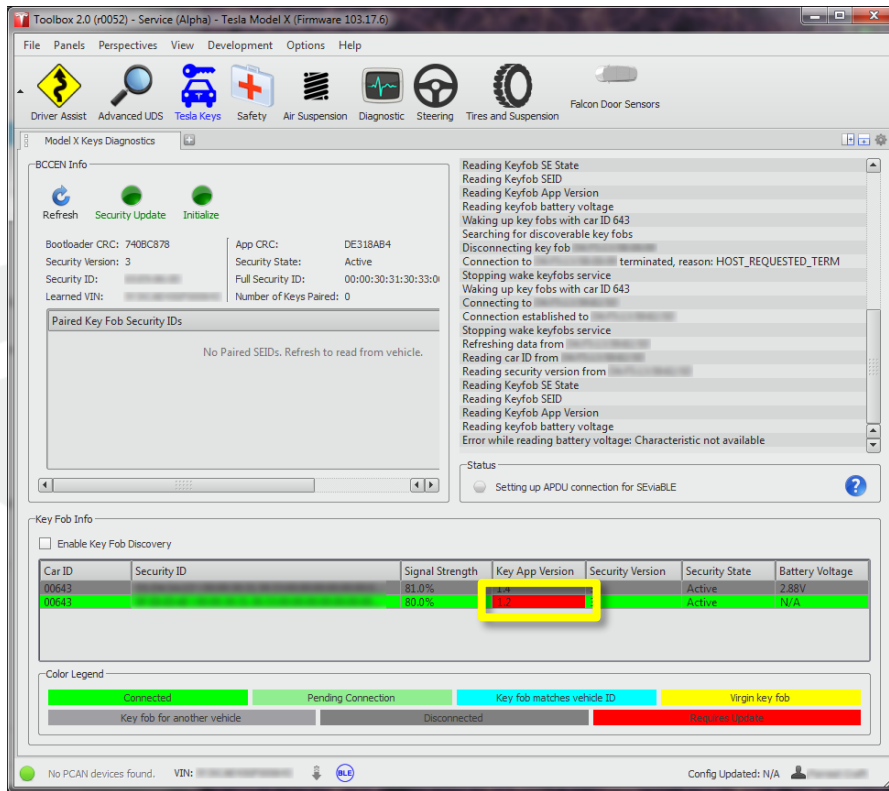
Figure 6

- If the color is green, skip to step 17.
- If the color is red (Figure 6), continue to the next step.

13. Right click the key and select **Verify Provisioning**.
14. Right click the key and select **Update Key App**.

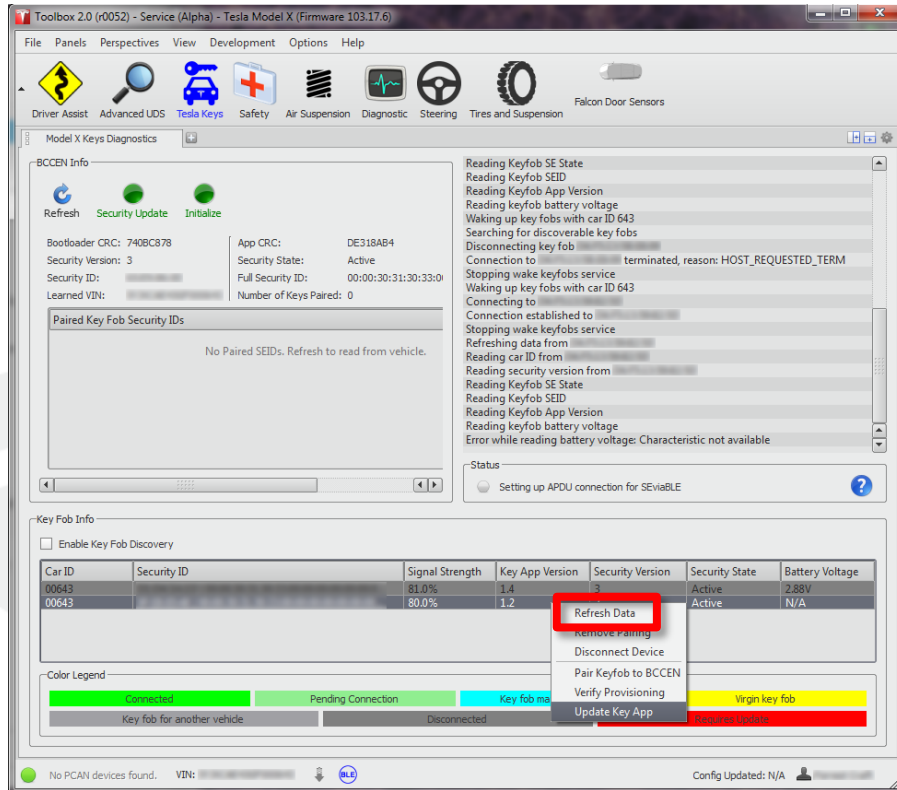
Figure 7

15. Right click the key and select **Refresh Data** (Figure 7).

**NOTE:** Ensure that the color displayed under “Key App Version” is green. If the color is still red, perform steps 13-16 again. Escalate a Toolbox session, as appropriate, if the color is still red after a second attempt.

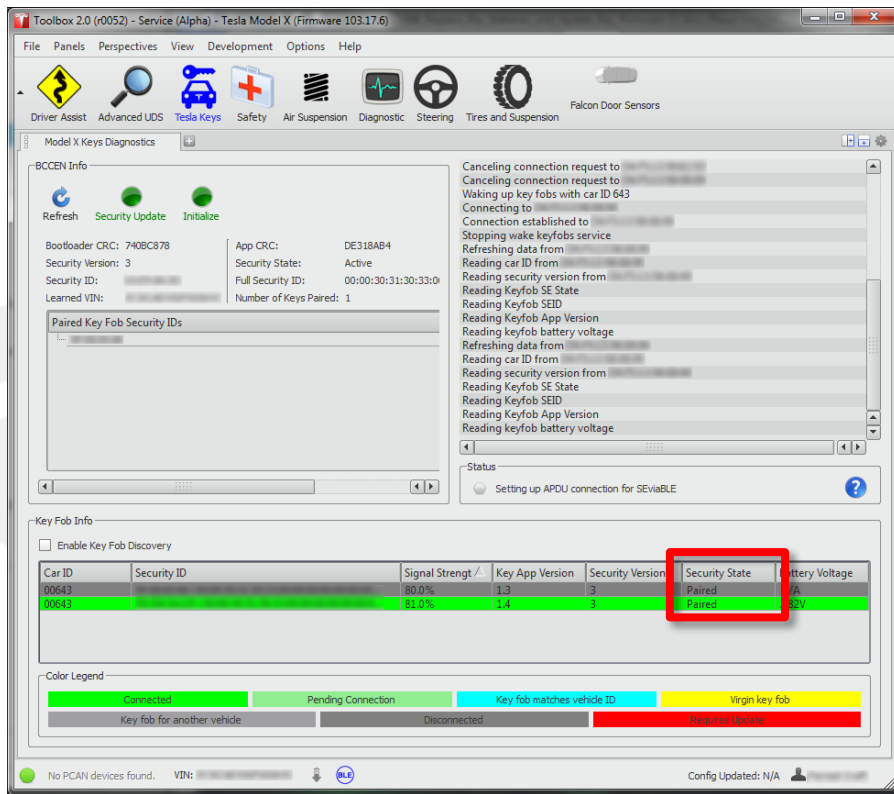
Figure 8

17. Ensure that the key displays “Paired” in the “Security State” field (Figure 8).

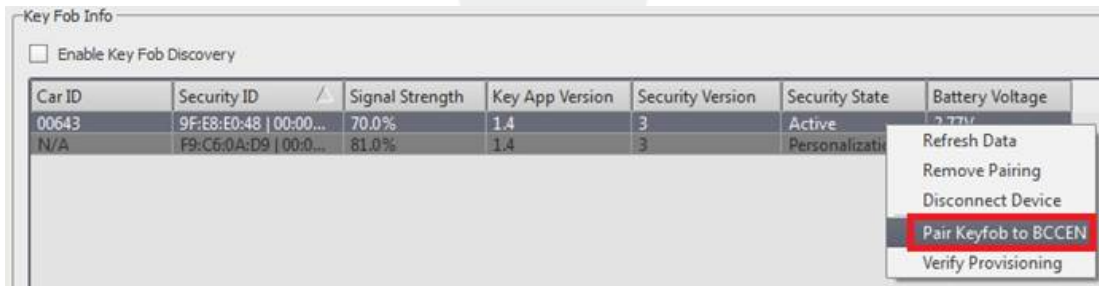
Figure 9

**NOTE:** If the key does not display “Paired”, right click and select **Pair Keyfob to BCCEN** (Figure 9).

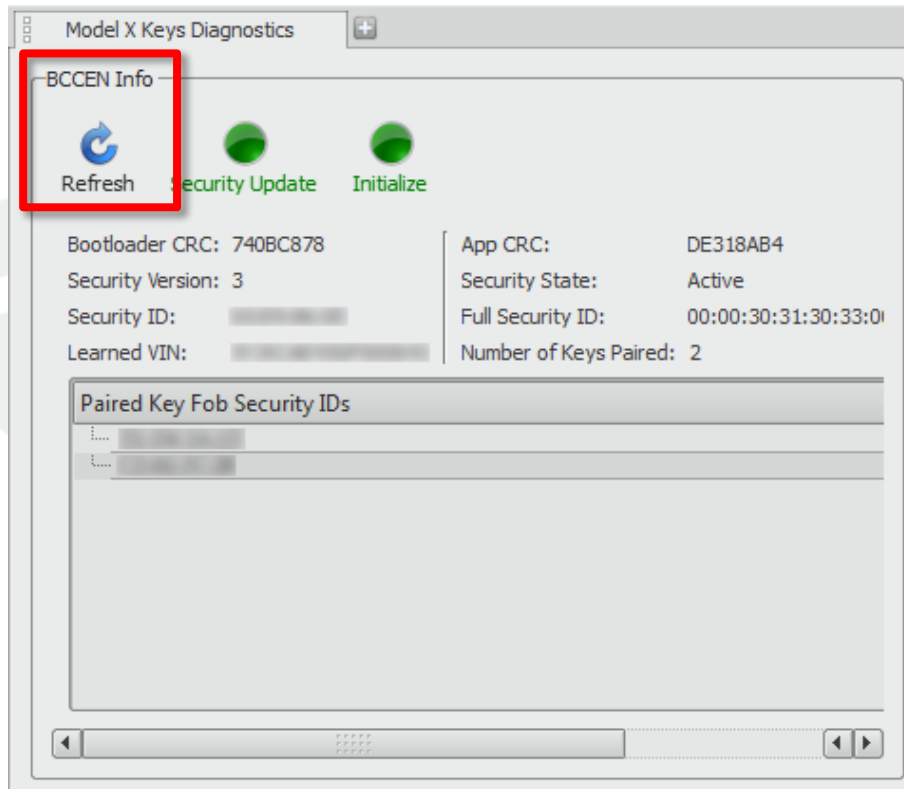
**Figure 10**

18. Perform steps 9-17 on the 2<sup>nd</sup> key, if available.
19. In the “BCCEN Info” field, click the **Refresh** icon (Figure 10).

**NOTE:** Ensure that the “BCCEN Info” section displays information for both keys. If the keys are not recognized, escalate a Toolbox session, as appropriate.
