Tesla, Inc. Service Bulletin		<i>Install Front Body Electrical Harness Cable Tie</i>	
SB-16-17-010 October 31, 2019		R1			
Classification			Section/Group		Mobile Service
Campaign Bulletin			17 - Electrical		Cannot Perform
Model Year	Model	Country/Region			Version
2016	Model S	All			Dual Motor
The model(s) and model year(s) listed are a general approximation of the affected VIN list. Refer to the VIN/Bulletin Tracker or Customer/Vehicle profile to determine applicability of this bulletin for a particular vehicle.

Condition

On some Model S vehicles, the G625 ground branch of the front body harness might have too much slack. This might cause chafing or other damage to the ground cable.

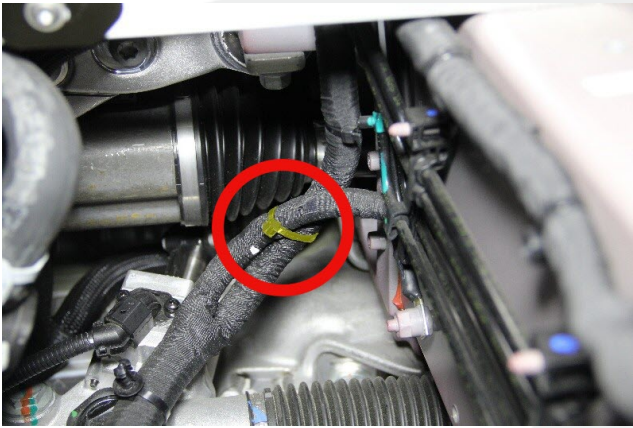
1. Remove the HEPA filter outlet duct (refer to Service Manual procedure 18105202).
2. Look through the space between the 12V battery and the shock tower to inspect the LH side of the front body harness near the LH front inner halfshaft assembly:
 - If a cable tie or electrical tape secures the G625 ground branch to the front body harness and no excessive wear is found on the G625 ground branch (Figure 1), reinstall the components that were removed for access and discontinue this procedure.
 - If there is no cable tie securing the G625 ground branch to the front body harness (Figure 2), continue to the next step.

✓ **Figure 1 – Cable tie highlighted**

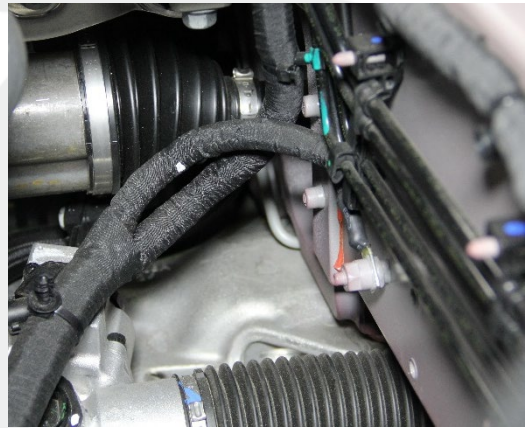
✗ **Figure 2– Cable tie missing**

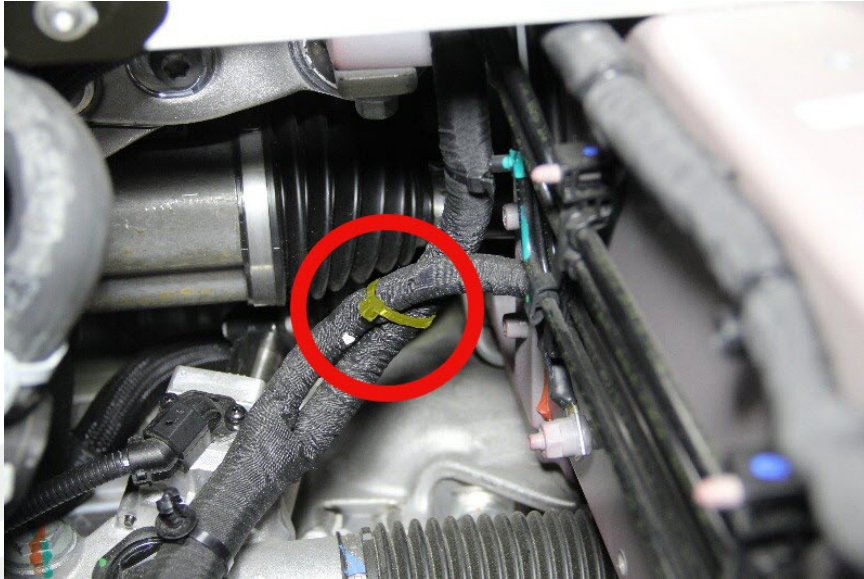
Figure 6 – Cable tie highlighted

9. Use a cable tie to secure the G625 ground branch to the front body harness as shown in Figure 6.

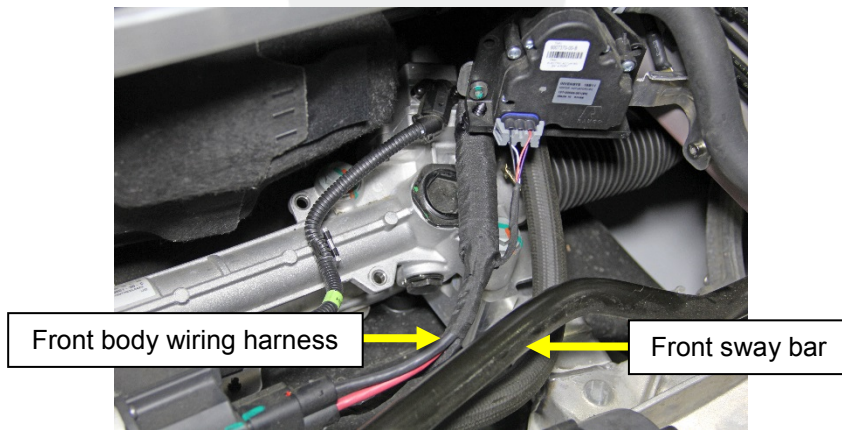
Figure 11 – Do not allow harness to touch sway bar

⚠ CAUTION: Do not allow the front body harness to touch the suspension front sway bar (Figure 11).
